Behaviour on Non-Loadbearing Tabique Wall
Subjected to Fire – Experimental and Numerical
Analysis

To appear in: *Journal of Building Engineering*

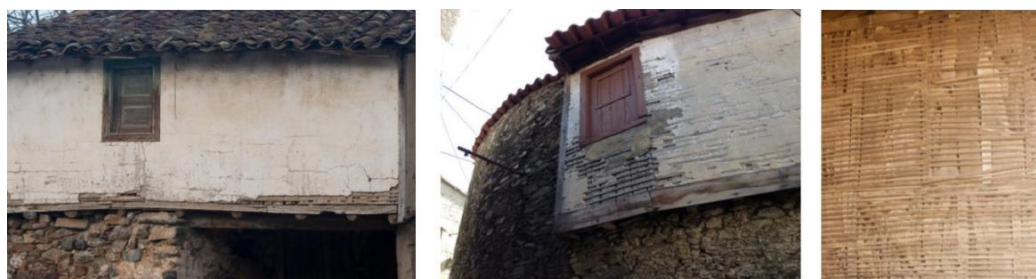
Fig. 1 *Tabique* wall building details.

structure was then covered with an earth-based render corresponding to a traditional building solution. Fig. 1 shows some building details of typical *tabique* walls.

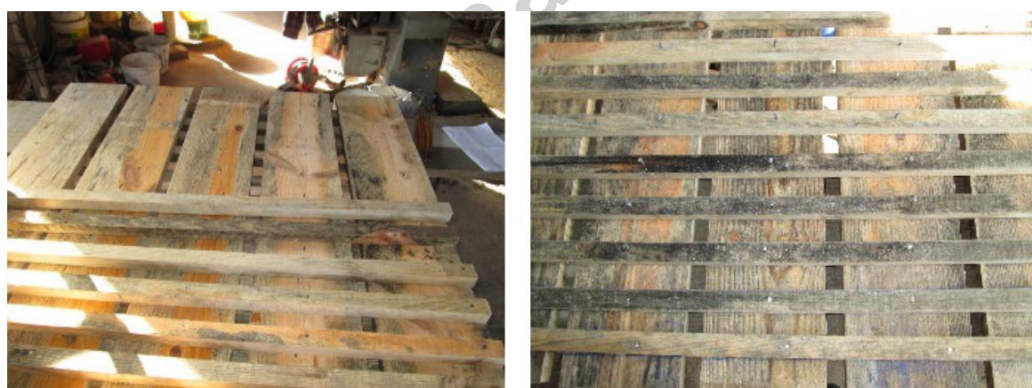
Fig. 2 Some stages of the manufacturing of the timber structure of the panels.

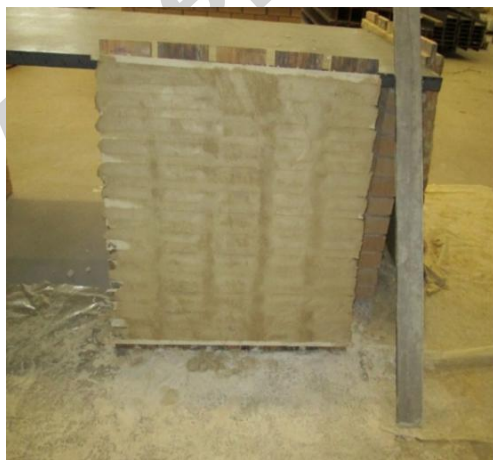
The timber structure of the panels was covered with an earth-based render applied on both sides. At a first stage, it was adopted the render composition delivered in previous studies [4] which do not considered lime or cement necessary. However, in this case and after some preliminary tests, it was concluded that it was convenient to include a 8% mass content of cement CEM II/B-L-32,5 R (white). The application of the render was performed in two main stages. In the first stage, the empty spaces of the timber structure were filled with the render (Fig. 4). In the second stage, the final coating was applied (Fig. 5). After this procedure, the panels remained in hygrometric controlled conditions of the laboratory for 30 days and they dried naturally at a room temperature around 18°C and air humidity of about 75%.

Fig. 4 Timber structure filled with earth-based render.

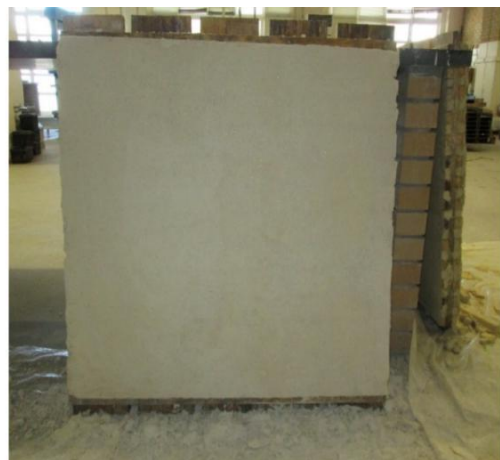
Fig. 5 Final coating.

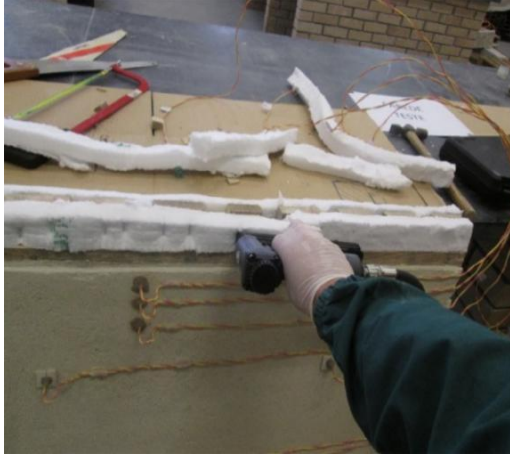
Before coupling the panel, a 50 mm thick rock wool was nailed along the perimeter of the panel in order to avoid gas or flame escaping between the rim and the panel, Fig. 7. The *tabique* panels were then fixed into a support and coupled to the furnace, Fig. 8.

Fig. 7 Isolation of *tabique* panel.

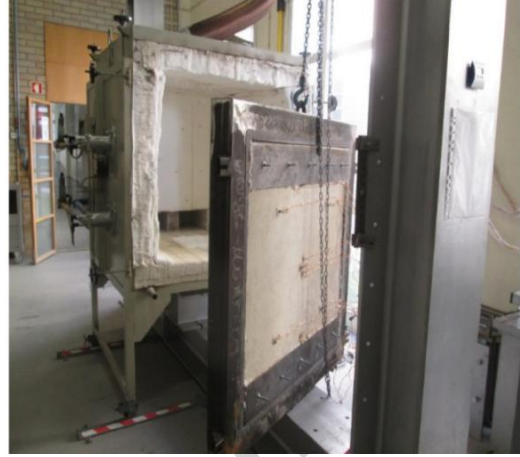
Fig. 8 *Tabique* panel coupled to the furnace.

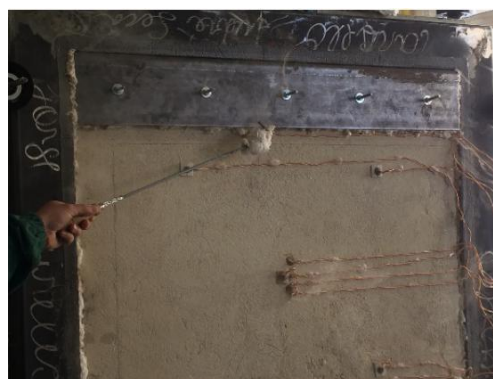
During the test, the integrity of the wall was evaluated throughout the cotton wool pads test (Fig. 10). The insulation of the panels was also evaluated during experiments by assessing the

Fig. 10 Integrity criterion proofing.

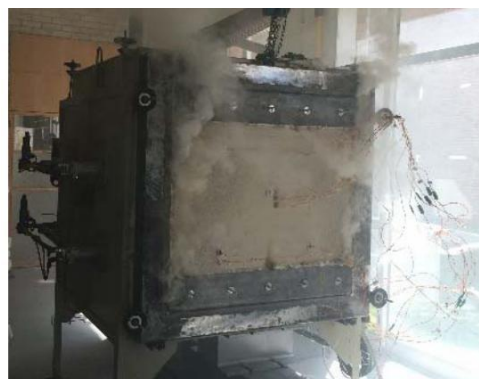
unexposed surface temperature according to European standard [10]. At the final stage of the tests, a significant amount of smoke releasing from burning wood (Fig. 11) was noticed.

Fig. 11 Smoke release.

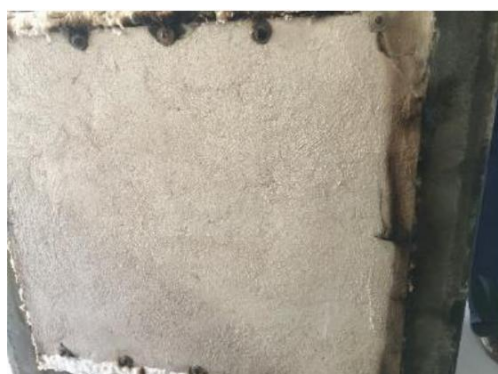
Fig. 12 *Tabique* wall panel at the end of the test.

The first tested sample was the wall panel with $t_h = 15$ mm of earth-based render. The lack of knowledge on *tabique* fire behaviour and the smoke release from the burning timber, which could indicate the ignition of the wood panel, led us to finish the test after 35 min. Fig. 12 shows the wall panel when the furnace door was opened. It can be observed that the earth-based render did not crack nor collapsed and that the laths burnt due to the small spaces created near the anchorage points of the wall panel. The earth-based render of the fire exposed surface of the panel was removed for a better perception of the fire effect on the laths, see Fig. 13. In general, it was noticed that the timber did not suffer significant damage. However, a char layer was created around the laths. In terms of the performance criterion, there was no deformation of the panel regarding load-bearing capacity. On the other hand, the integrity criterion was also verified because there was no flame or ignitions of the cotton. At the same time, the insulation criterion was as well verified taking into account that the higher value of temperature measured in thermocouple TD3 was of 55°C.

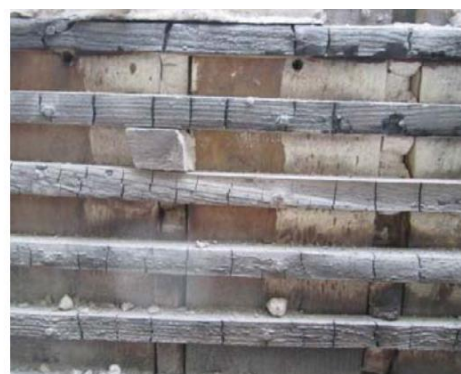
Fig. 13 Timber structure after the test.

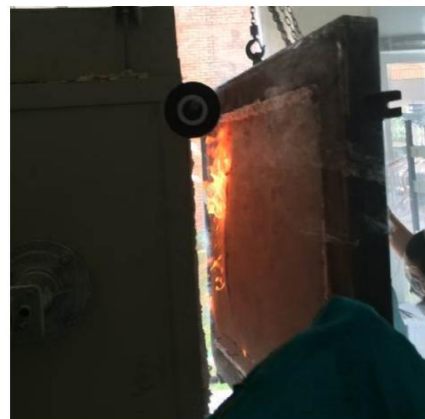
From the analysis of the results obtained in the previous test ($th = 15$ mm) it was decided to extend the test duration from 35 min to 60 min in this case (*tabique* wall panel with $th = 10$ mm). Nevertheless, both insulation and integrity criteria were met. The recorded temperatures of the unexposed surface of the panel were always below 90°C . There was also no deformation of the panel. Fig. 14 shows the timber structure burning during the test. Meanwhile, Fig. 15 shows the panel in flame when the door of the furnace was opened.

Fig. 14 Flame from wood combustion. **Fig. 15** *Tabique* wall panel when the door was opened.

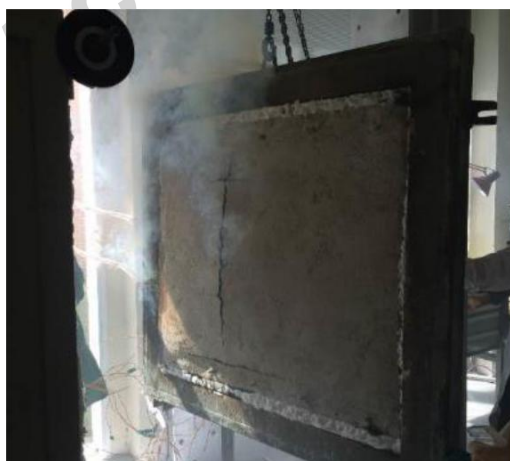
Afterwards, the flame was extinguished and the *tabique* wall panel was forced to cool using tap water. At this stage, it was possible to observe the existence of cracks in the exposed surface of the panel. A large vertical crack was formed at the centre of the *tabique* wall panel and also some other small ones in horizontal direction (Fig. 16). The final aspect of the timber structure can be observed in Fig. 17, which shows the complete carbonization of the horizontal (laths) and the vertical timber elements of the *tabique* wall panel. Based on the scale of damage caused to the *tabique* wall panel and the large amount of smoke release it was decided to shorten the duration of the third test.

Fig. 16 Cracks in the earth-based render.

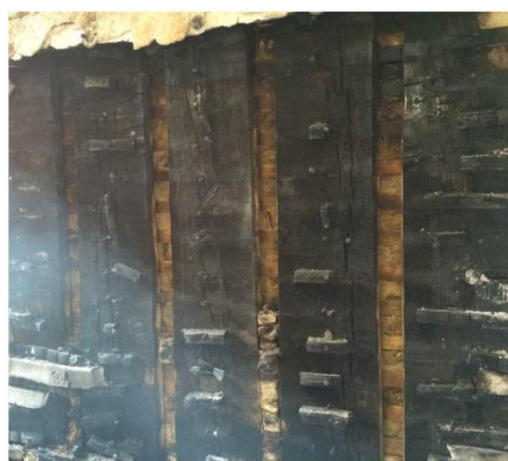
Fig. 17 Timber structure after the test.

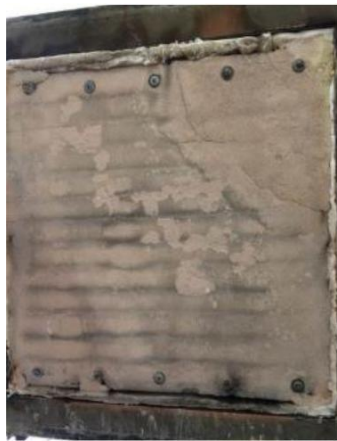
Fig. 18 *Tabique* wall panel after opening the furnace door.

The third *tabique* wall panel ($th = 5$ mm) was tested during 15 min, which was the duration found to be the one corresponding to the plateau of the graphs that can be observed from Fig. 28 to Fig. 32. When the furnace door was opened and the *tabique* wall panel was cooled (using water spray), the fire exposed surface presented signs of spall. In fact, the earth-based render layer separated rapidly from the wooden structure due to the thermal shock generated by the water particles in contact with the hot surface. Fig. 18 shows the aspect of the *tabique* wall panel at the end of the test and Fig. 19 shows the timber structure after removing the earth-based render layer. It is possible to verify that the timber structure remained intact. In terms of the performance criterion, it was also verified that there was no deformation of the panel. The integrity criterion was also met because there was no flame or ignitions of the cotton. Finally, the insulation criterion was as well met since the higher temperature value measured by thermocouple TD3 was 21°C .

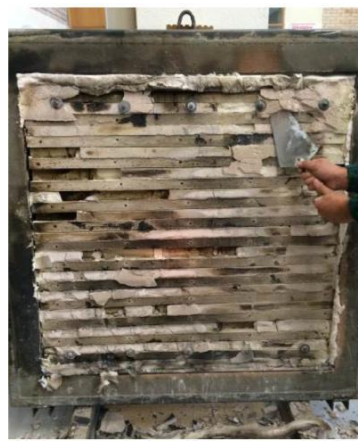
Fig. 19 Timber structure after the test ($th = 5$ mm).
