Bond strength characterization of commercially available grouts for masonry

Eduarda Luso^{a,*}, Paulo B. Lourenço^b^a ISISE, Polytechnic Institute of Bragança, Department of Civil Constructions, Campus Sta Apolónia, 5300-253 Bragança, Portugal^b ISISE, University of Minho, Department of Civil Engineering, Azurém, 4800-058 Guimarães, Portugal

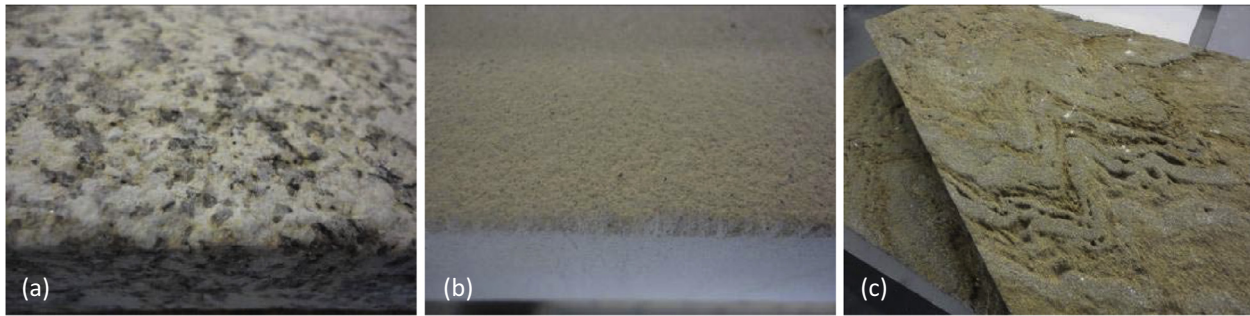
Fig. 1. Aspect of the stones used in the tests: (a) yellow granite (YG); (b) limestone (LS); (c) schist (SC).

The experimental program presented in this paper focuses mainly on the study of the bond strength of injection grouts available in Europe with three different types of stone, namely yellow granite (YG), limestone (LM) and schist (SC), commonly used in ancient masonry walls existing in Portugal (see Fig. 1). The grouting materials chosen for this study were: Mape-antique I, from Mapei, Albaria Iniezione from BASF, Calce per Consolidamento from Cepro and Lime-Injection from Tecnochem. These products are denoted hereafter by A, B, C and D respectively, for conciseness. The description and the properties of each grout according to the respective producer are presented in Luso and Lourenço [31].

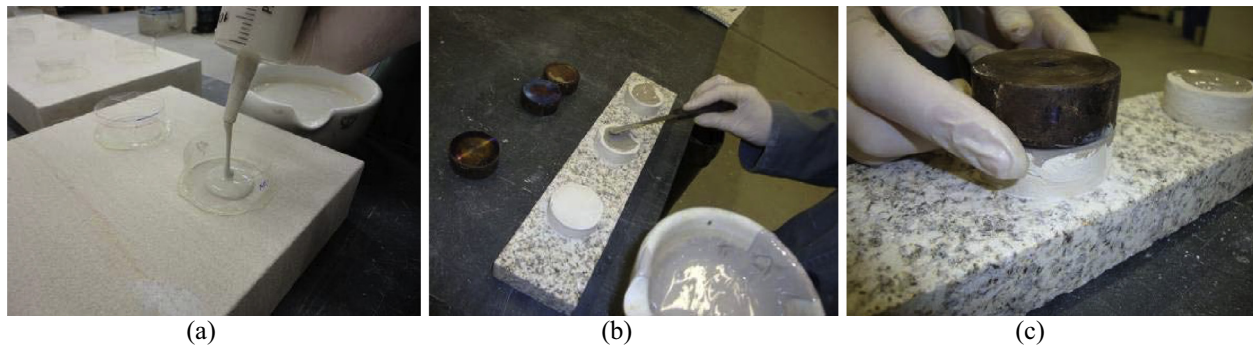
Fig. 2. Sequence for specimens preparation: (a) grout filling of disk with syringe; (b) application of epoxy after disk curing; (c) gluing of pulloff disk.

The specimens thus formed (stone + grout) were subjected to curing in a humid chamber with $T = 20\text{ °C} \pm 2\text{ °C}$ and $RH \approx 95\%$. The mould release (removal of transparent tape) occurred about two weeks after the preparation of the test specimens. In order to level the surface of the grout specimens and remove the bright skin that forms in some of the grouts, the surface was ground with fine sandpaper. Approximately 48 h before the tensile test, circular metal discs with a diameter of 48 mm were fitted on one side of a centred thread and they were glued with high strength epoxy resin (see Fig. 2(b and c)).

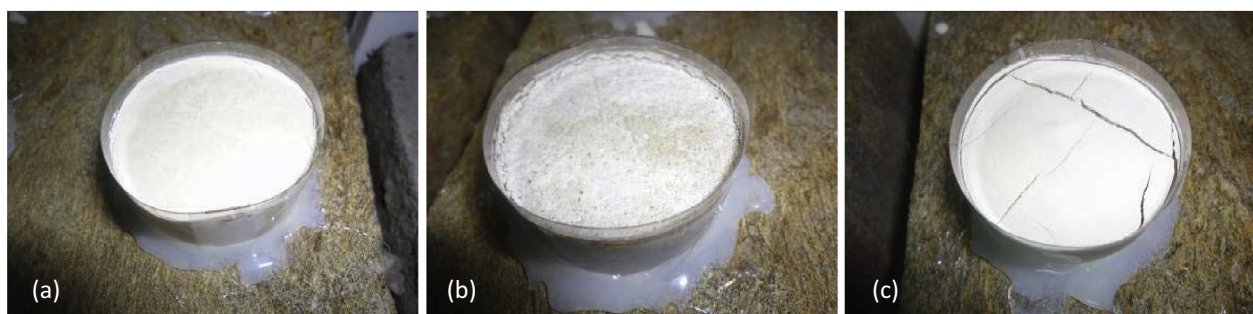
Fig. 3. Aspect of the test pieces after a few days of curing and before demoulding: (a) A; (b) D and (c) C

Product C presented, for most specimens, transverse cracking at the upper edges, most likely due to shrinkage, sometimes separating the grout specimen into two parts and therefore conditioning the results (see Fig. 3). Product D showed a variation of colour and texture over the height of the disk, with stratification. This phenomenon is not surprising, given the exudation/segregation tests. Products A and B present, in general, a smooth texture and a uniform colour with no cracking.

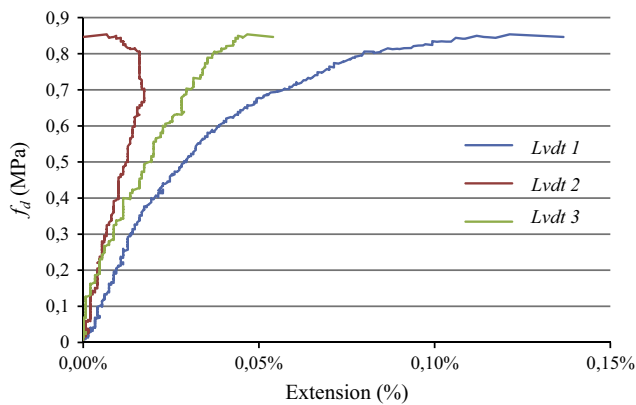
Fig. 5. Experimental result on the tensile bond strength of the interface between the A grout and yellow granite.

Three LVDT’s of $\pm 2.5\text{ mm}$ were placed at a 120° angle in the sample (see Fig. 4), allowing one to obtain stress-displacement diagrams only up to the maximum value of the stress (see Fig. 5).

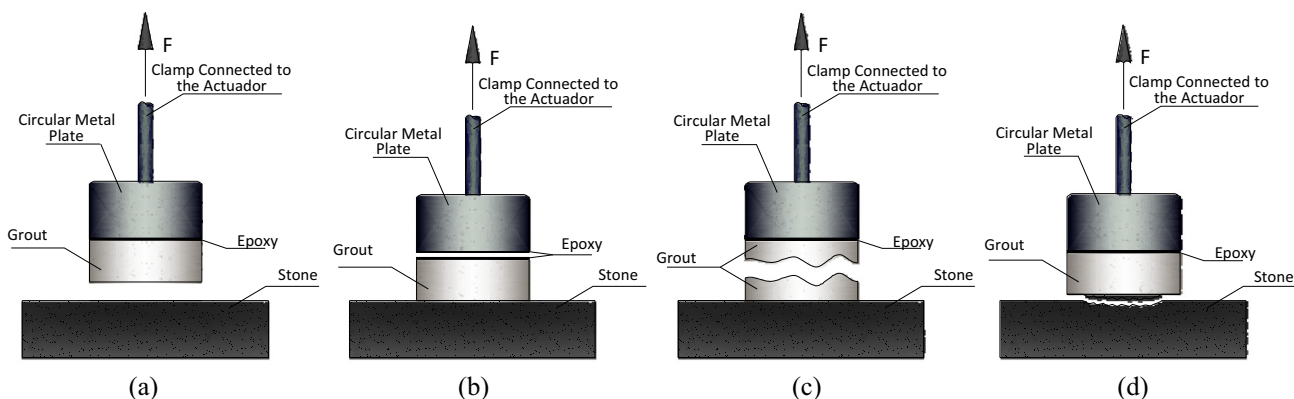
Fig. 6. Fracture type scheme: (a) interface; (b) glue; (c) grout and (d) stone.

For each pulloff test, the failure mode obtained was identified. The knowledge of the type of failure is essential because the ultimate strength obtained in the test can be the bond strength of the interface or a lower limit, depending on whether the fracture is adhesive or cohesive [40]. The bond failure can occur between the grout and stone (denoted in what follows next as “interface”) or between the grout and the circular metal plate (denoted as “glue”) (see Fig. 6(a and b)). In the case when the fracture occurs in the glue, the test is considered unsuccessful, and the value obtained is a minimum pulloff strength for this specimen type. When fracture occurs within the grout or at the support, it is called a cohesive fracture (Fig. 6c and d). Next, this fracture is denoted as “grout” and “stone”, respectively. It is noted that several failures involve mixed modes.

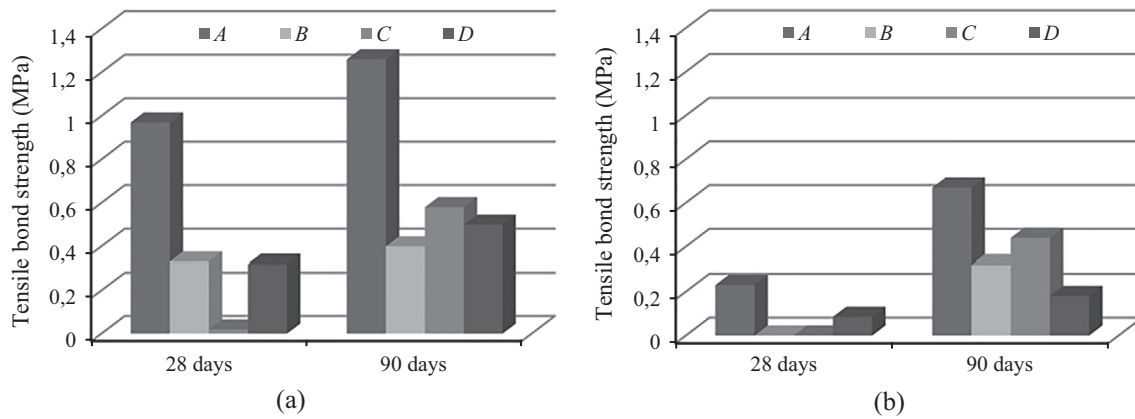
Fig. 7. Results in YG: (a) “wet”; (b) “saturated”.

Figs. 7–11 present graphically all the tensile bond strength results for easier comparison. The overall analysis indicates that

the best results are obtained with granite in the “wet” condition. In this case, a bond stress of 1.26 MPa was obtained at 90 days of age. Products C and D presented values near 0.7 MPa in the “dry” state at 90 days of age, close to the values obtained at 28 days in the granite. Poor results were obtained in granite in the “wet” and “saturated” states. In limestone, the results are significantly worse than with granite. In this case, it was impossible to perform the test in the majority of the samples, as detachment of the grout occurred prior to the specimen being tested in the laboratory. For schist the results obtained are below those for granite, although grout A had satisfactory results (see Figs. 8–10).

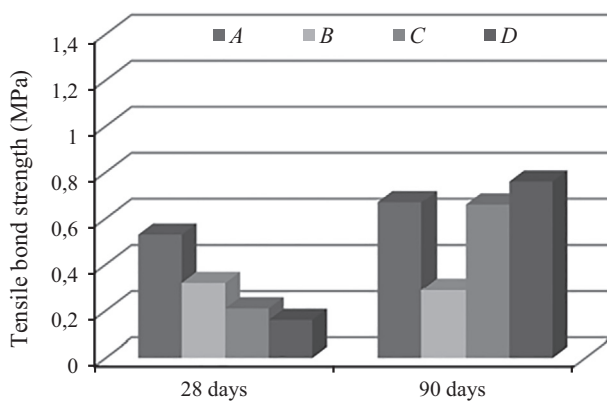
Fig. 8. Results in YG “dry”

Reasonable results were also obtained for “dry” granite, which allowed the conclusion that even with low porosity and no excess of water, the bond strength appears to be more effective with more roughness, but this property is also linked to the type of grout used and to the petrographic characteristics of stones.

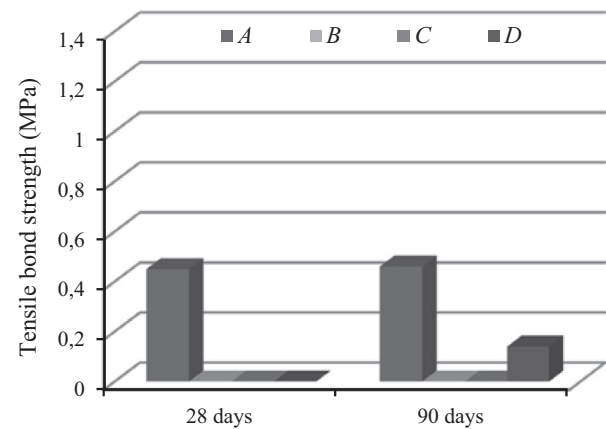
Fig. 10. Results in LM “dry”.

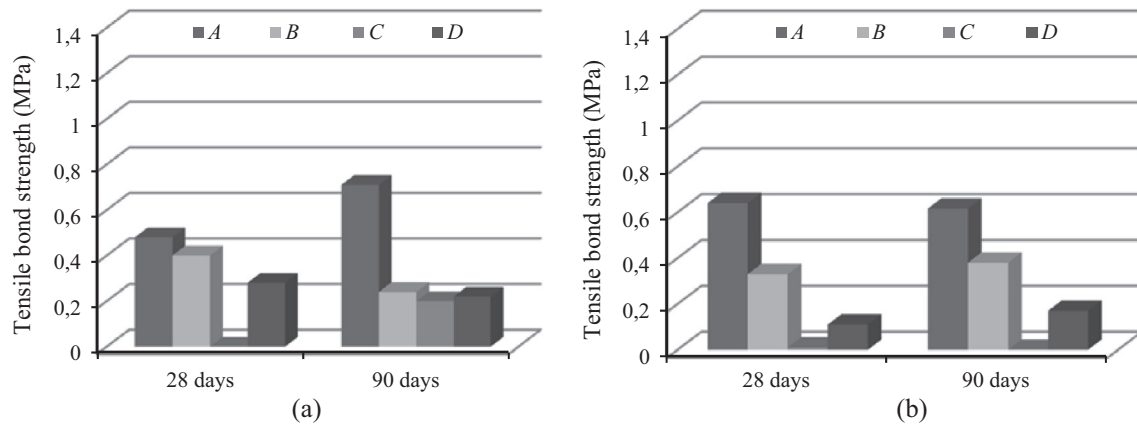
Fig. 11. Results in SC: (a) "wet"; (b) "dry".

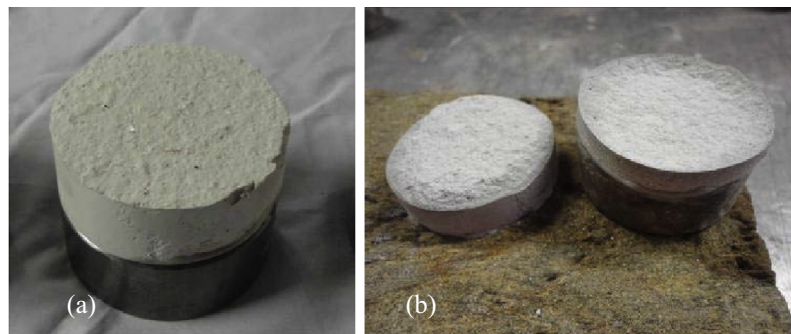
Fig. 12. Types of fracture observed: (a) "interface" with product D; (b) "grout" with product D.

the “dry” state, grout A showed fracture mainly in the “interface”, but with a good bond and a slight detachment of the schist. This type of failure was not observed in the remaining grouts. Grouts B and C always exhibited an “interface” failure. The failure mode of grout D was often a “grout” failure. Conversely, “glue” failure never occurred, which indicates that a proper epoxy was adopted in the tests. Figs. 12 and 13 show examples of each type of fracture observed during the tests.

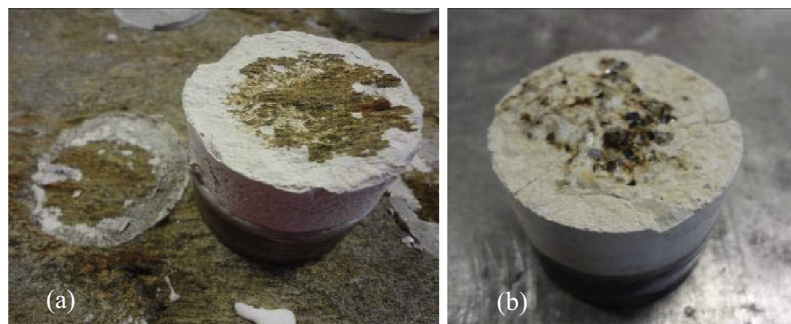
Fig. 13. Types of fracture observed: (a) interface + stone with product A and "dry" schist; (b) "stone" with product A and "wet" granite.

During testing, stone fracture was observed in granite, but only for grout A, which seems to provide a better mechanical connection between the support and the grout. The fracture by cohesion of stone was more pronounced in the “wet” than in the “dry” condition and increased with the age of the specimen. In schist stone in
