Mechanical Behavior of Two-Leaf Masonry Wall—Strengthening Using Different Grouts

Eduarda Luso, Ph.D.¹; and Paulo B. Lourenço, Ph.D.²

Author keywords: Schist masonry; Grout; Injection; Walls.

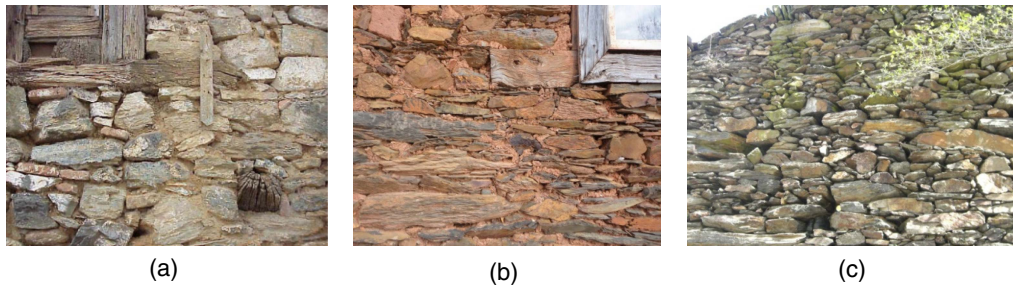
Fig. 1. Schist masonry walls: (a and b) with mortar joints; (c) with dry joints.

Schist constructions are an important cultural, architectural, and historical legacy in Europe, and particularly in Portugal, whose preservation is of importance. There are many buildings of schist masonry spread all over Portugal, varying in terms of building typology, constructive techniques, and even type of schist (Barros et al. 2010). Schist masonry in northeastern Portugal typically has two types of constructions: with mortar joints, usually with mixtures based on clay or lime, or with dry joints, normally used in encircling walls, mills, and shelters (Fig. 1).

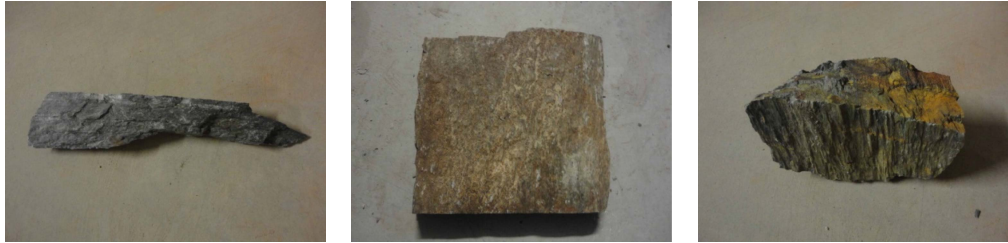
Fig. 2. Appearance of schist stones after cutting with hammer and pointer.

cut according to the required shape for the wall construction, resulting in irregularly shaped stone pieces (Fig. 2). The schist, kept packed on pallets, covered with plastic, and placed outside until the time of wall construction, presented an average moisture

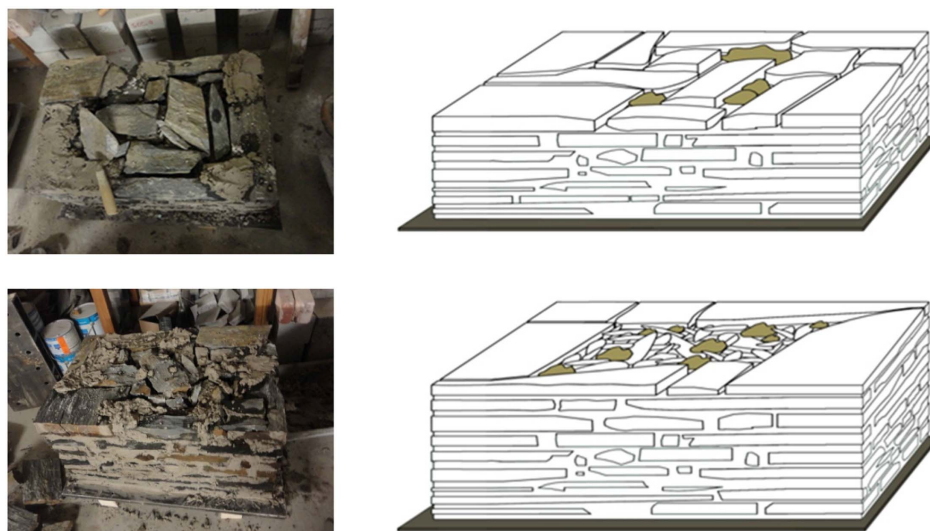
Fig. 4. Construction of the walls.

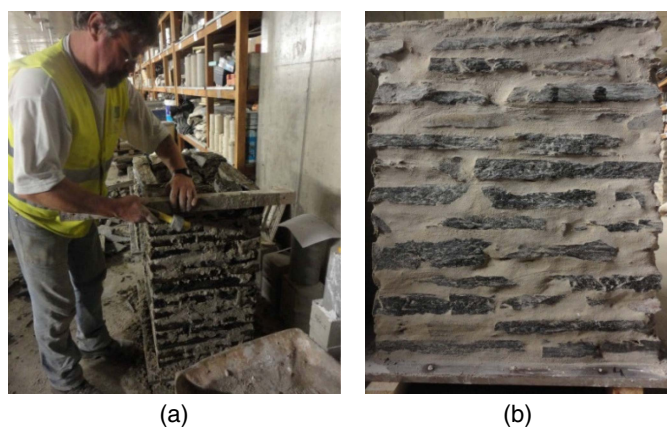
Fig. 5. (a) Construction of the walls; and (b) final aspect of Wall P4.

The wall specimens were 0.70 m wide, 0.89 m high, and 0.45 m thick. The final aspect of one of the walls can be seen in Fig. 5(b). For details on the construction sequence, height of courses, average thickness of horizontal joints, and geometrical details of the walls, see Luso (2012). The walls remained in place after construction for 10 weeks' curing, and then the grouting work began.

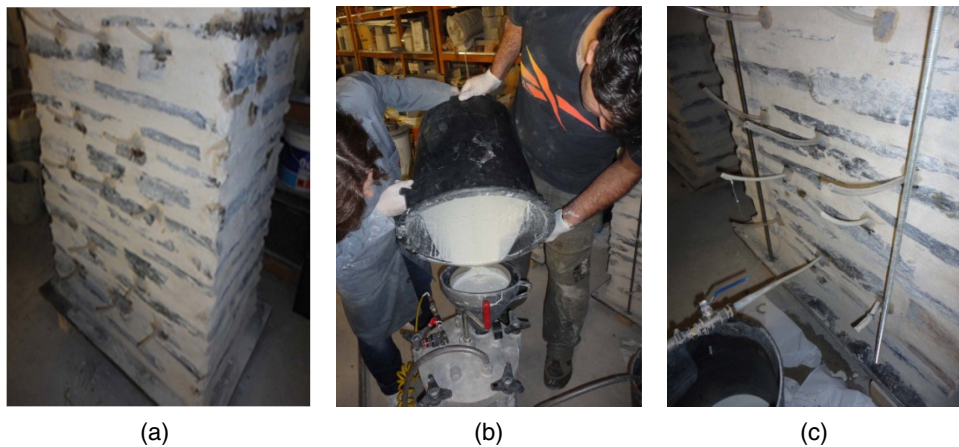
Fig. 6. (a) Wallet final aspect before grouting; (b) introduction of grout in the pressure pot; and (c) injection of the walls.

Once the walls were prepared, the grout was introduced at low pressure (around 1.5 bar) in the interior using a pressure pot, starting from the bottom up to the top of the wall.

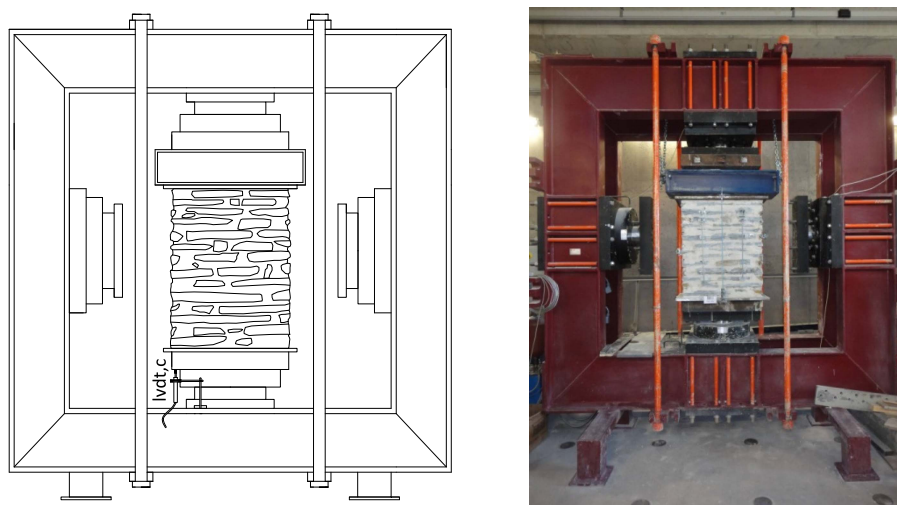
Fig. 7. Test setup of the walls: scheme and testing machine.

All wall specimens were tested under monotonic compression using a 2-MN closed-loop servo-controlled testing machine (Fig. 7). The tests were performed under displacement control at a constant

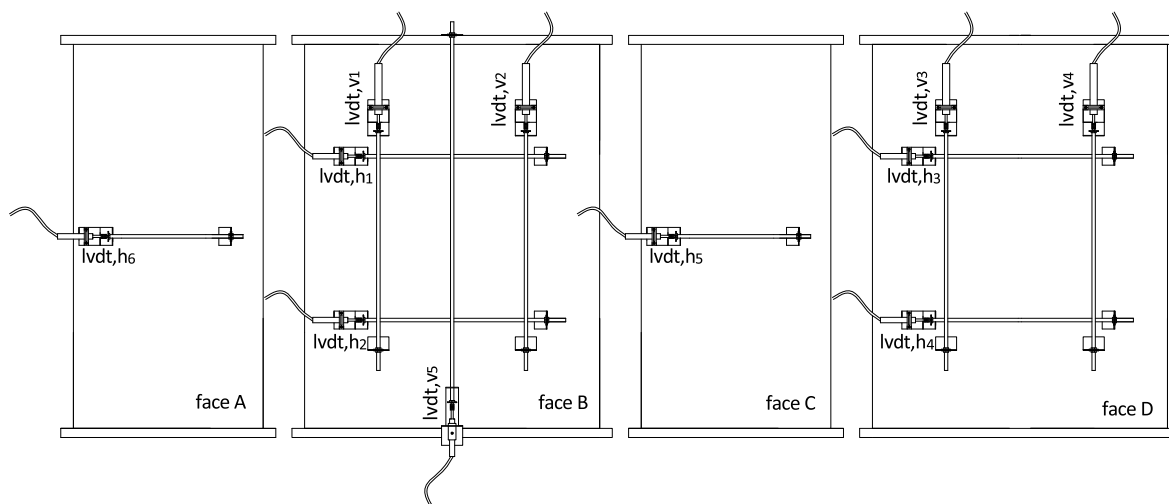
Fig. 8. Test setup of the walls: location of the displacement transducers (Faces a, b, c, and d are, respectively, left, front, right, and back with respect to Fig. 7).

rate of $5 \mu\text{m/s}$. During the tests, the displacements in the walls were measured by means of linear variable displacement transducers (LVDTs) disposed according to Fig. 8. The LVDT layout in the walls aimed at measuring vertical, horizontal, and transversal

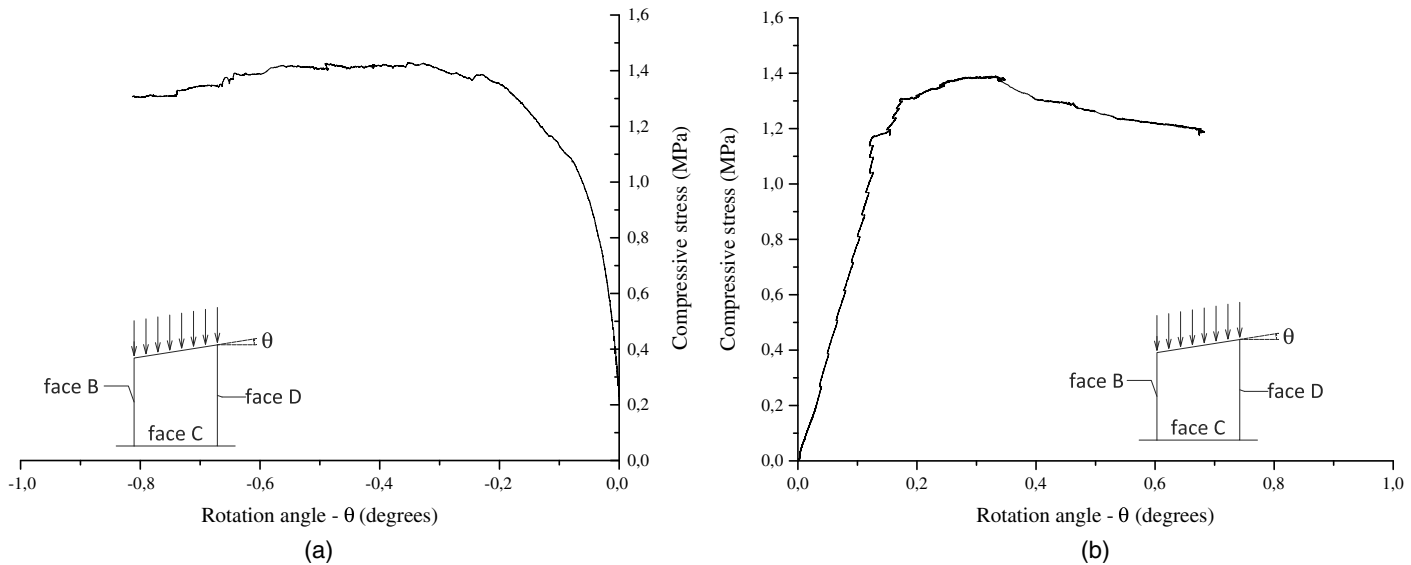
Fig. 10. Compressive stress versus angle of rotation of the walls: (a) P4 nI; and (b) P5 nI.

In Fig. 9, a good approximation between the displacements verified in the internal (average of values obtained in LVDTs v1 and v2; see Fig. 7) and external (LVDT v5) schemes can be seen in Face B for walls P4 nI and P5 nI. There was some difference between measurements on Faces B and D, as usual in this type of test due to inevitable rotation, or nonsymmetric failure, of the specimen in the postpeak regimen. Fig. 10 shows the variation of the angle of rotation with the stress level installed.

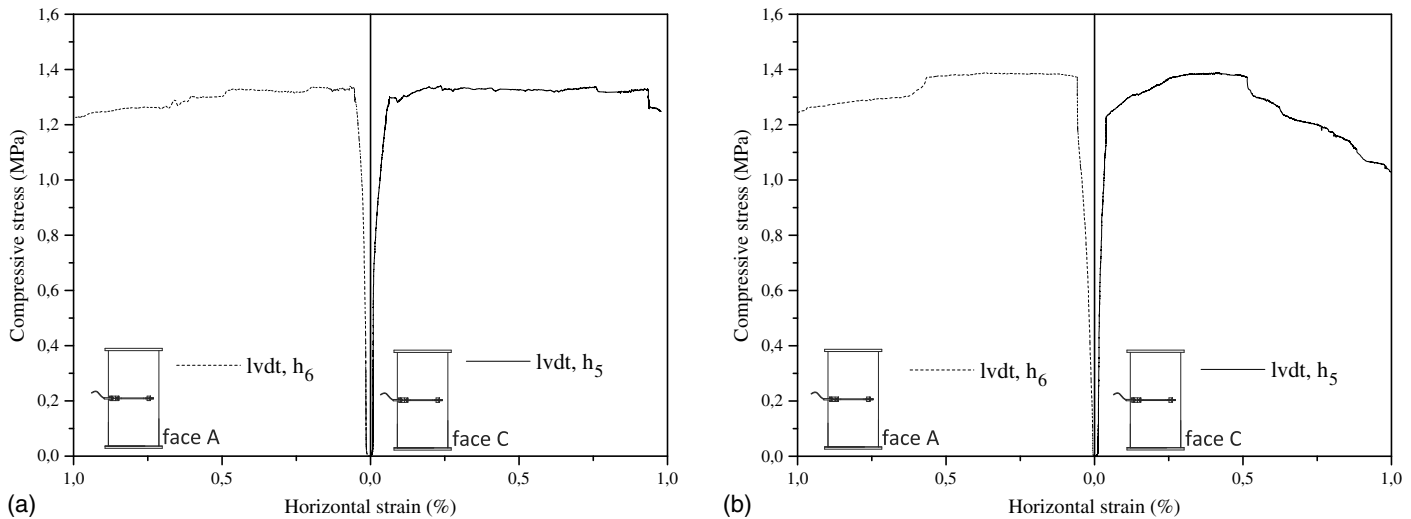
Fig. 11. Compressive stress–horizontal strain graphs on Faces A and C: (a) P4 nI; and (b) P5 nI.

In relation to the horizontal deformation recorded on the transverse Faces A and C (Fig. 11), values of the same order of magnitude were observed in both walls (Faces B and D) (Fig. 12) because the number of joints in the measuring field was identical (at most, one or two joints between the LVDTs). The graphs of Fig. 11 show that transverse deformation occurred fundamentally and abruptly at load values close to the peak load and increased significantly after rupture. These results are similar to most failures of single-leaf masonry walls, which occur in the transverse direction.

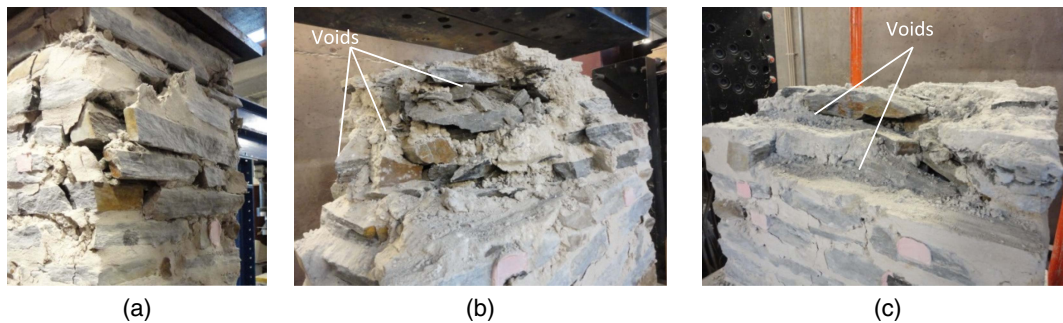
Fig. 16. (a) Detail of the detachment of stones on Face A on Wall P4 nI; (b) aspect of the interior of Wall P4 nI during disassembly; and (c) appearance of the interior of Wall P5 nI during disassembly.

The cracking pattern of walls P4 nI and P5 nI at the end of the test is shown in Figs. 13 and 14. Up to an axial stress level of 50% of $f_{c,w}$ in Faces B and D and Faces A and C, only a small number of cracks of predominantly horizontal orientation was observed, resulting from the crushing of the mortar joint, and small cracks were also observed at a 45° angle between joints. For values close to the maximum load, the cracking pattern had a vertical predominance marked by the breaking of the stone elements. There was also a predominance of those slits in the upper part of the wall. This phenomenon can be seen in the graphs of Fig. 15, which relate the horizontal extension of the walls recorded in the horizontal transducers placed on Faces B and C to the height of the wall. It can be seen that the transducers placed in the upper zone of the wall measure larger extensions than those placed in the lower zone, possibly due to the execution of the walls. It is also possible to verify in these graphs that, until a level of axial tension near 50% of the breaking load, the deformation is negligible. At the end of the test, the width of the cracks varied, with larger cracks reaching values of 5 or 6 mm. In the case of Wall P4 nI between Faces A and C, a localized outward detachment of its elements was observed; see Fig. 16(a). The appearance of the interior of the noninjected walls during the dismantling can be seen in Figs. 16(b and c).

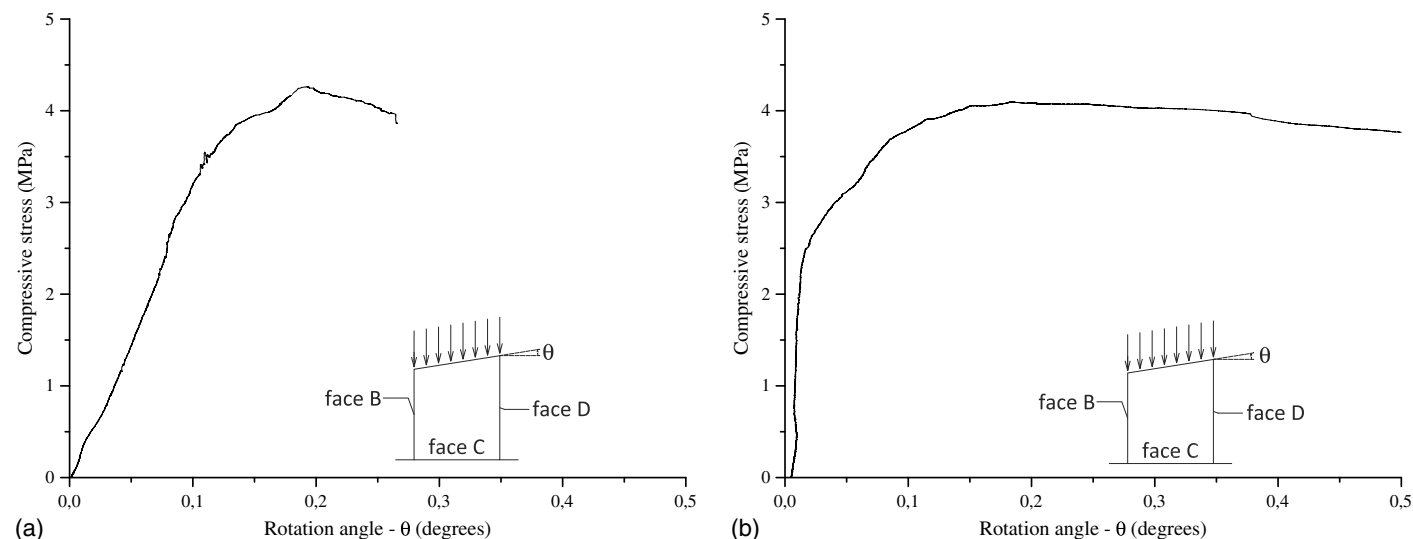
Fig. 19. Compressive stress–rotation angle of the walls: (a) P1 IB; and (b) P3 IB.

displacements in the internal scheme (average of values obtained in LVDTs v1 and v2) and in the external scheme (LVDT v5) in Face B for walls P1 IB and P6 IA. However, in walls P3 IB and P2 IA, there was some difference (Fig. 18). In these two walls, the curvature of the graph at the initial phase of the test showed a more pronounced concavity associated with some adjustment of the steel plates to the test wall specimen. Comparing the measurements on Faces B and D with respect to the vertical deformation, an increase in wall rotation from about 60% of the maximum load was observed on Wall P3 IB. The evolution of the rotation of the strengthened walls with the applied stress level can be seen in Figs. 19 and 20.

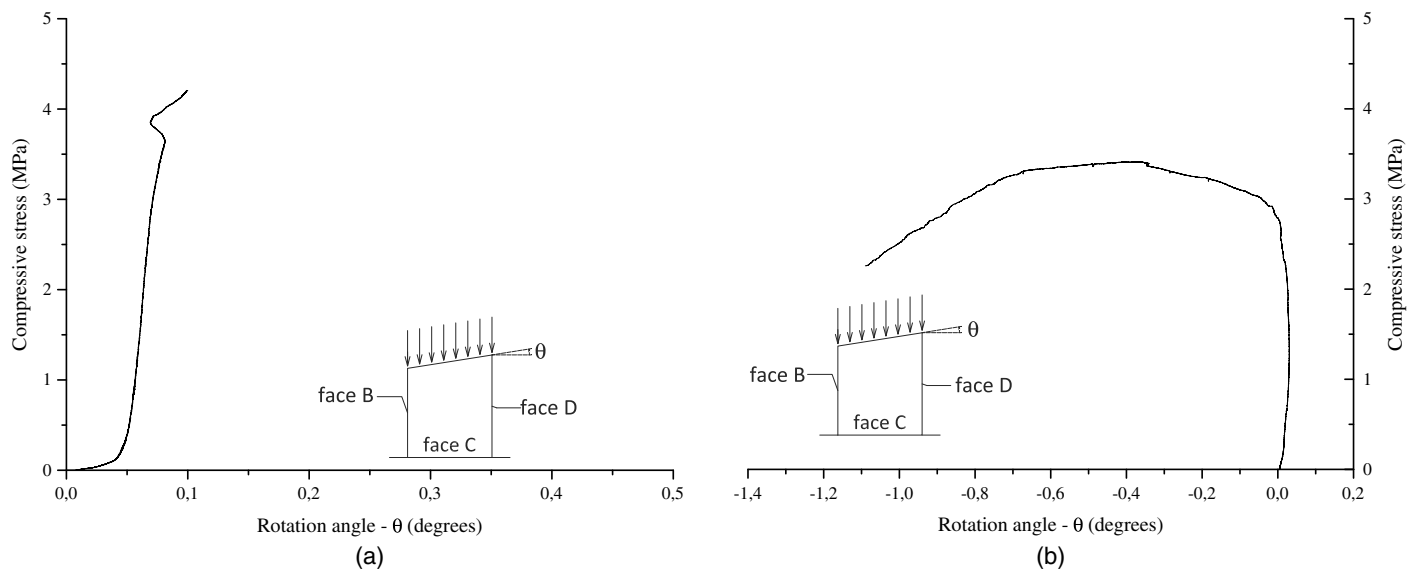
Fig. 20. Ratio of compressive stress versus angle of rotation of the walls: (a) P2 IA; and (b) P6 IA.

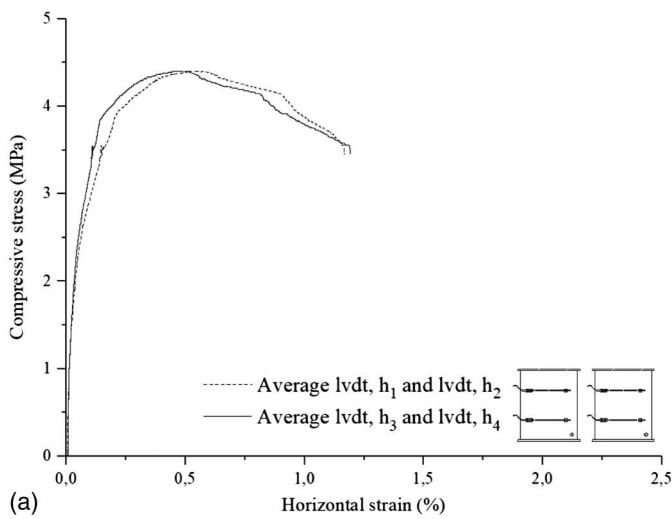
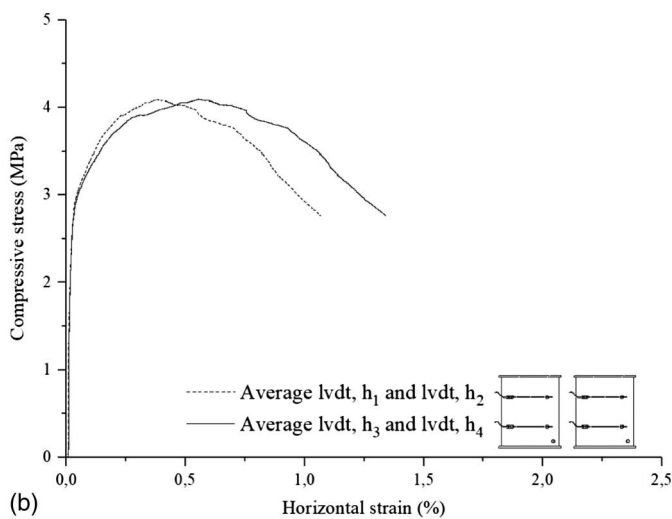
Fig. 21. Compressive stress–horizontal extension graphs: (a) P1 IB; and (b) P3 IB.

Regarding the horizontal deformation, the deformations of the transverse Faces A and C (Figs. 21 and 22) were similar to those of Faces B and D (Figs. 23 and 24).

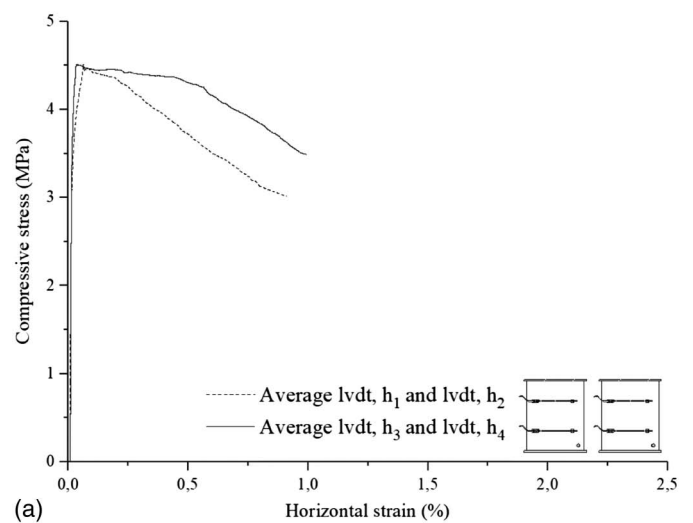
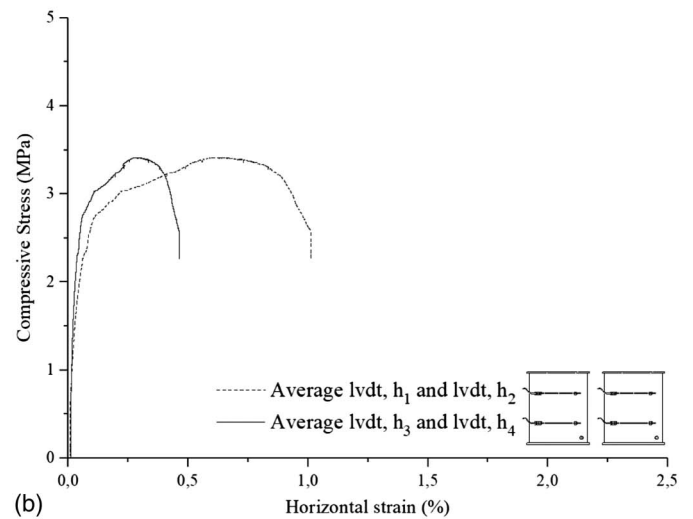
Fig. 22. Compressive stress–horizontal extension graphs: (a) P2 IA; and (b) P6 IA.

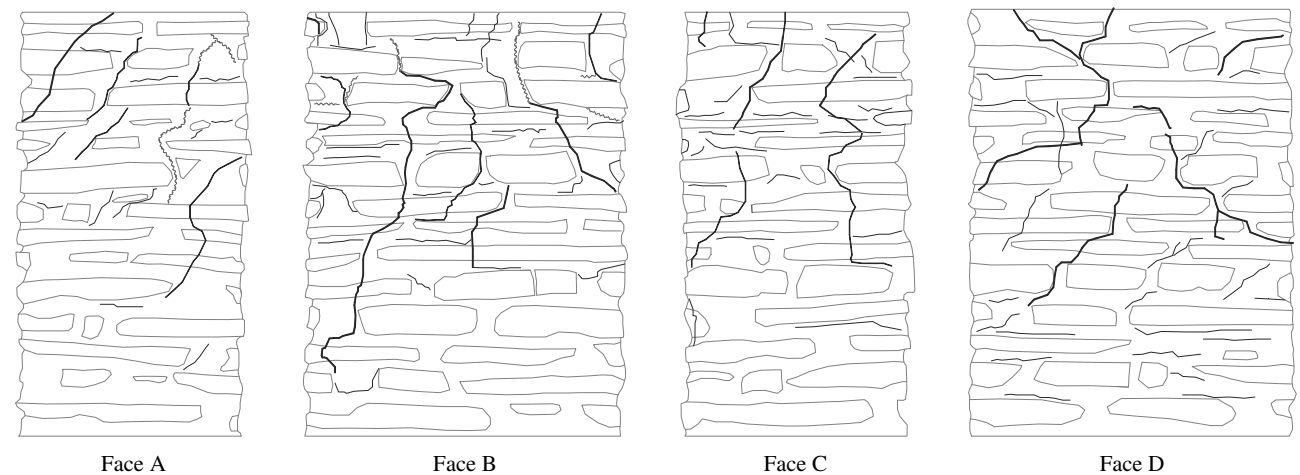
Fig. 28. Crack pattern corresponding to the end of the test in P6 IA.

The cracking pattern of walls P1 IB and P3 IB is shown in Figs. 25 and 26, respectively, and for walls P2 IA and P6 IA in Figs. 27 and 28, respectively. On Wall P6, the cracks prior to the test, which arose at the time of the injection of the wall, are shown in zigzag lines and grey color.

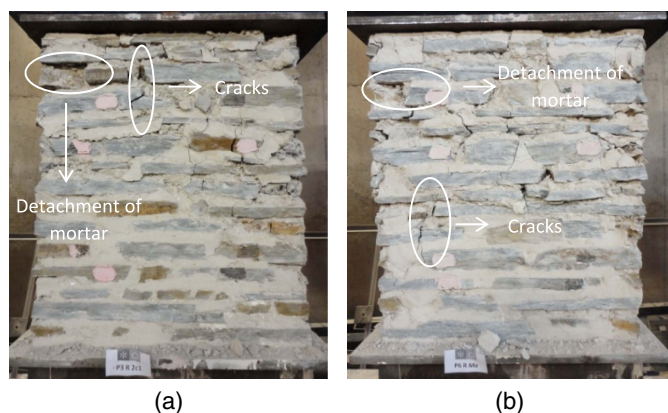
Fig. 29. Collapse mechanism of the walls: (a) P3 IB; and (b) P6 IA.

The first cracks arose at about 50%–60% of the maximum load. Similarly to the unreinforced walls, these cracks are visible only in the mortar joint, with a predominantly horizontal direction, which indicates the crushing of the mortar. For a load level close to 90% of the maximum load, the cracking intensified and the breakage of the stone elements was already visible. Also, in this case, there was vertical cracking with detachment of the grout joint

and out-of-plane movements (Fig. 29). In the case of Wall P6 1A, a localized rotation on Face A was found near the top of the plane after reaching the maximum load. This latter effect resulted in the measurement of a displacement lower than the one actually experienced. This phenomenon was responsible for the fact that, near

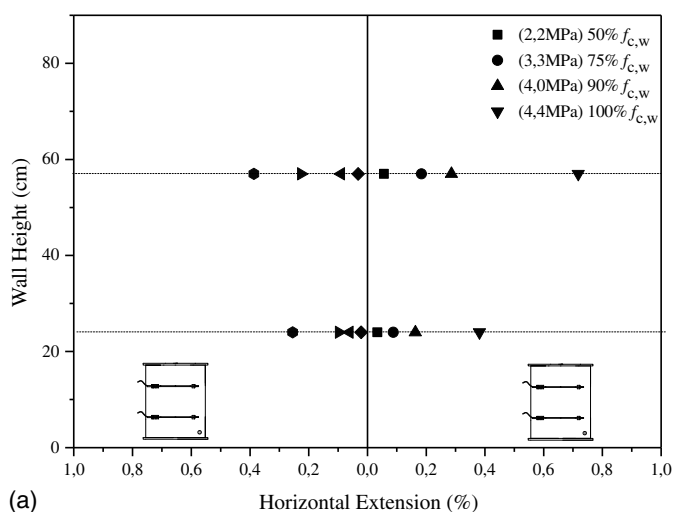
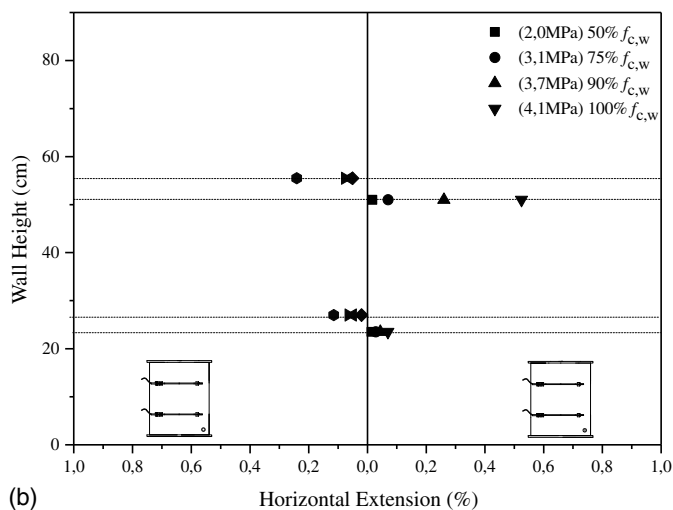
Fig. 30. Variation of the horizontal extension with the variation of load and height of the wall: (a) P1 IB; and (b) P3 IB.

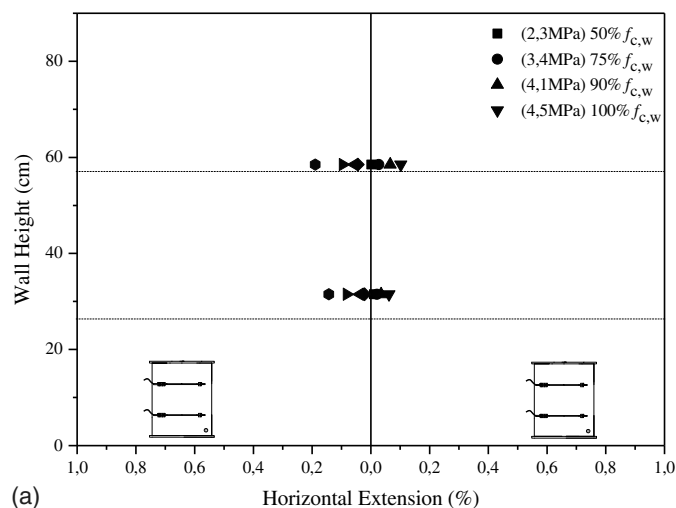
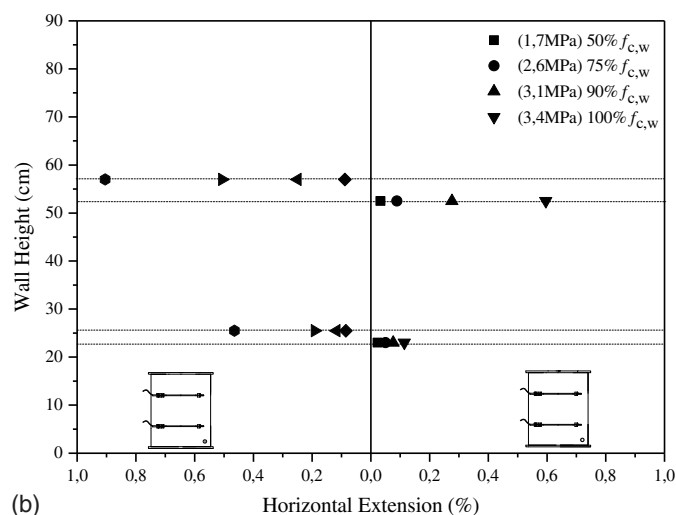
Fig. 31. Variation of the horizontal extension with the variation of load and height of the wall: (a) P2 IA; and (b) P6 IA.

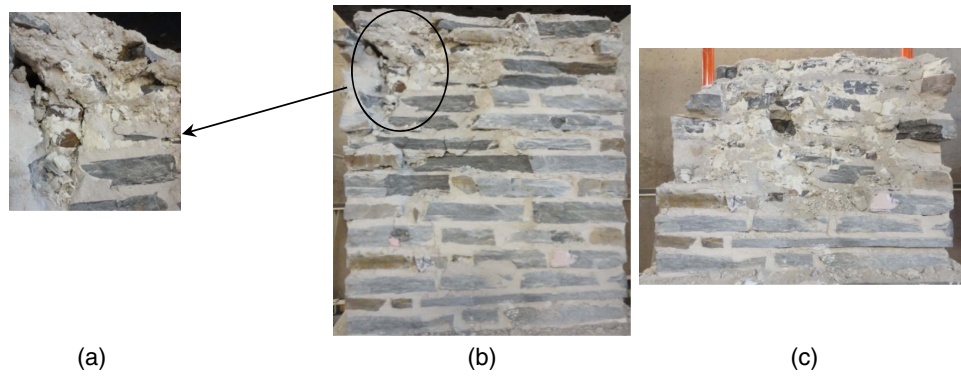
Fig. 32. Appearance of the interior of Wall P1 IB: (a) detail of the top; (b) top of the wall; and (c) wall base.

the end of the test, there was a change of direction of the displacements measured in LVDTs v_1 and v_2 . From the analysis of the cracking distribution, it can be seen that, similarly to the unreinforced walls, there was a predominance of cracks in the upper zone, as shown in Figs. 30 and 31. The appearance of the interior of the injected walls during the dismantling can be seen in Figs. 32 and 33. Comparing these results to those of Fig. 16, where the existence of voids in the noninjected specimens is clear, in these pictures, it is possible to check that injected grout was very well distributed for both grout types, filling the voids of the wall.

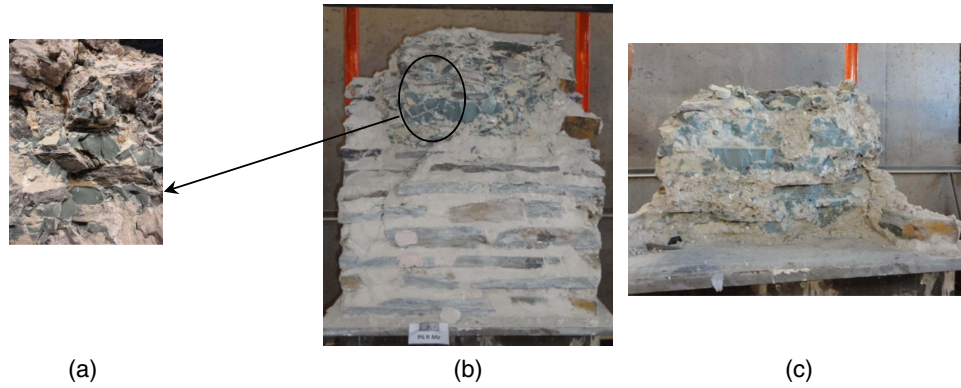
Fig. 33. Appearance of the interior of Wall P6 IA: (a) detail of the top; (b) top of the wall; and (c) wall base.

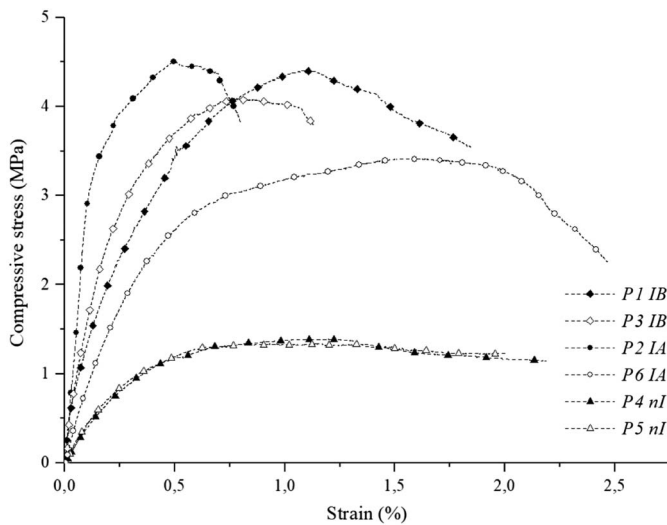
Fig. 34. Compressive stress-strain graphs for all tested walls.

Following the analysis of the results of each wall, Fig. 34 shows the vertical stress–strain diagrams for the six walls tested, with and without grouting, in order to facilitate comparison. In Table 6, the average values obtained in each type of strengthened wall are compared with the mean values obtained on the unstrengthened walls. It is found that the injection significantly increased the compressive strength of the walls (about three times) and also the stiffness of the walls, about five times. The two grouts seem to have performed similarly in terms of strength and initial stiffness.

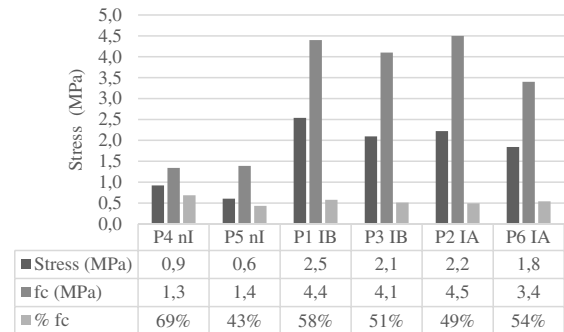
Fig. 35. Compressive stress level for which the first crack with horizontal direction appears versus maximum compressive strength.

The appearance of the first horizontal and vertical cracks, as well as the respective applied load, is given in Figs. 35 and 36, respectively. On average, the first horizontal cracks appeared at about 50% of the maximum load, whereas vertical cracks arose at about 80% of the maximum load. Crack initiation was defined by the LVDTs and is rather objective, corresponding to a significant increase of measurements.

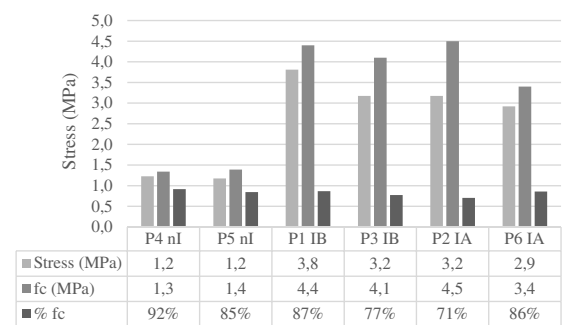
Fig. 36. Compressive stress level for which the first crack with vertical direction appears versus maximum compressive strength.
