Nonlinear Dynamic Analysis for Safety Assessment of Heritage Buildings: Church of Santa Maria de Belém

João Roque¹; Daniel V. Oliveira²; Tiago Miguel Ferreira³; and Paulo B. Lourenço⁴

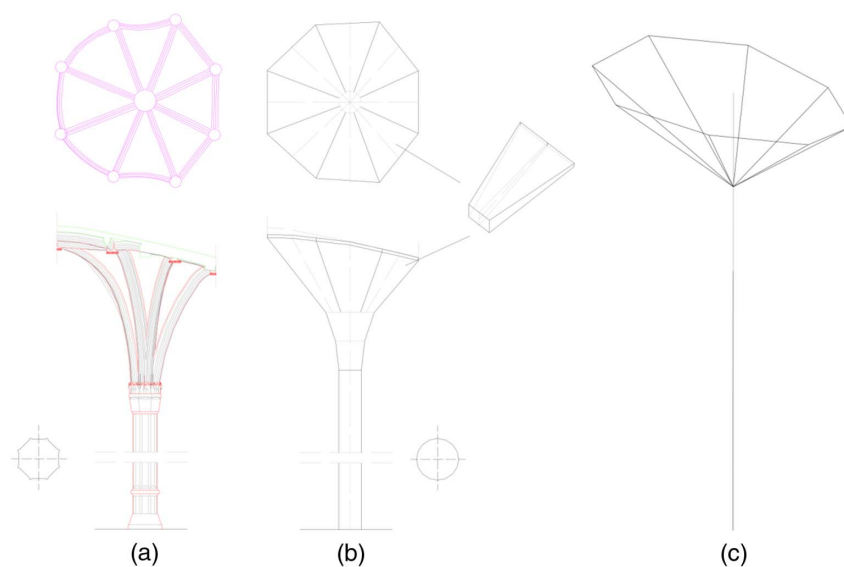
Fig. 5. Finite-element model: (a) existing; (b) approximated configuration; and (c) geometric model adopted for the columns. (Reprinted from Construction and Building Materials, Vol. 116, M.-G. Masciotta, J. C. A. Roque, L. F. Ramos, and P. B. Lourenço, "A multidisciplinary approach to assess the health state of heritage structures: The case study of the Church of Monastery of Jerónimos in Lisbon," pp. 169–187, © 2016, with permission from Elsevier.)

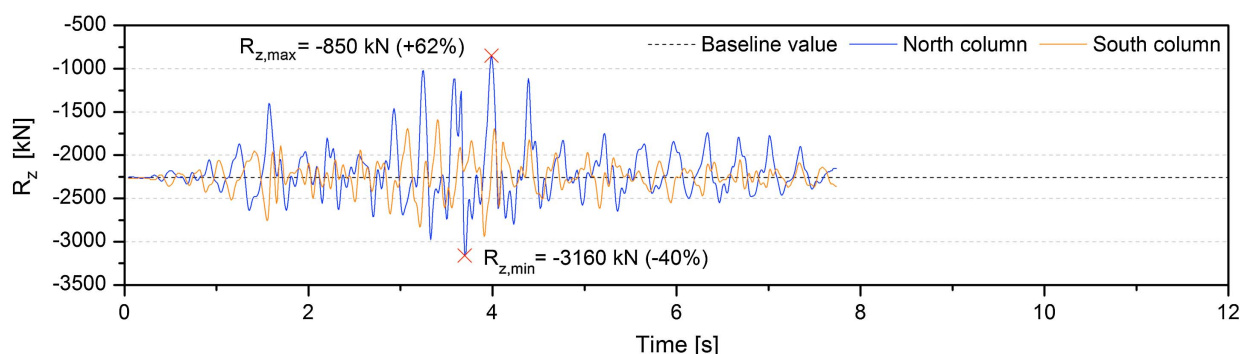
**Fig. 6.** Time history of vertical reactions at the north and south columns for a return period of 475 years (seismic input 475_M74_3).

In the direction transverse to the nave, the seismic response of the central arcade denotes a clear frame action (column-wall) resulting in high axial load variations in the columns ranging from -90% to $+91\%$ with respect to gravity load (return period of 5,000 years) (Figs. 6–8). The changes in structural performance can be clearly observed from the horizontal reaction time-history response of the columns (Fig. 9); the collapse begins with a sudden reduction on the north column (about 12–13 s) and is accompanied by an increase on the south column.

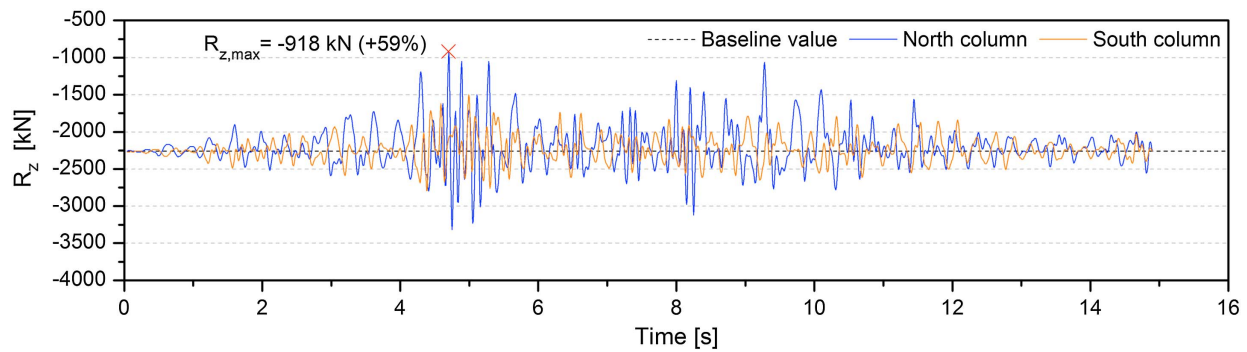
Fig. 7. Time history of vertical reactions at the north and south columns for a return period of 975 years (seismic input 975_M78_1).

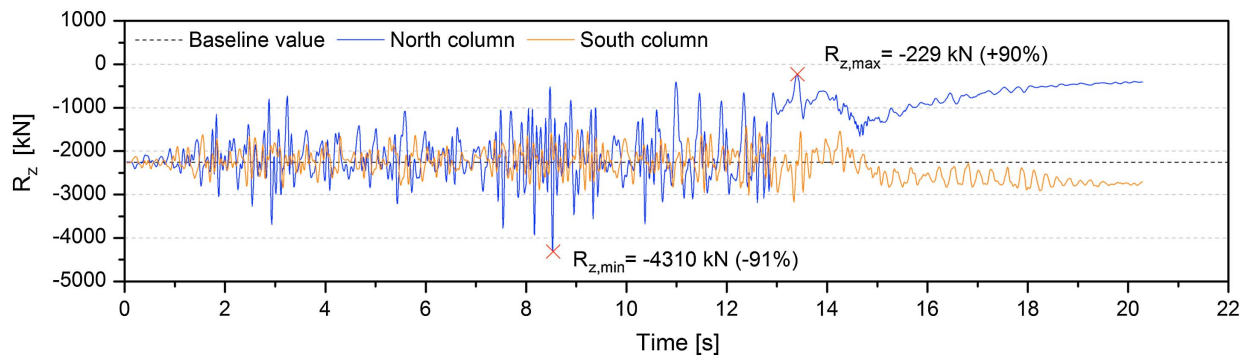
Fig. 8. Time history of vertical reactions at the north and south columns for a return period of 5,000 years (seismic input 5000_M82_2).

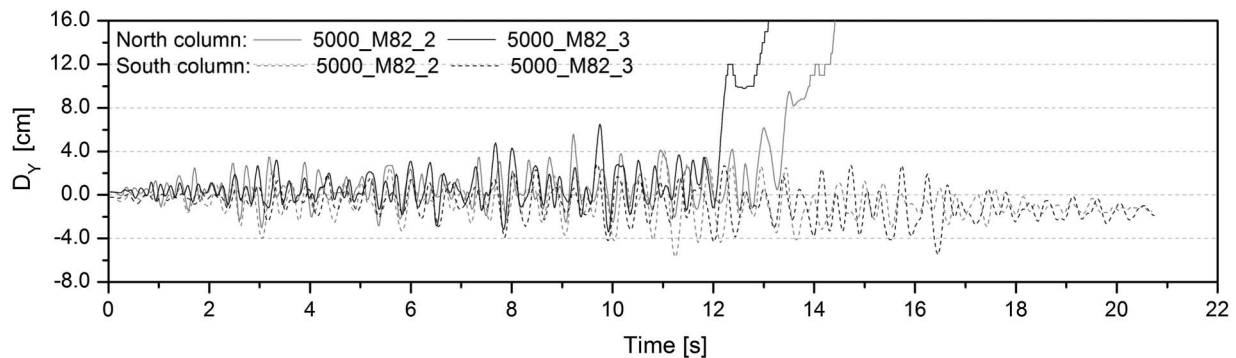
Fig. 9. Time history of horizontal displacements at the shafts of the north and south columns.

These changes are also evident in the horizontal deformability of the central arcade, mainly concentrated at the column shafts. However, the low amplitude of the transverse displacements

indicates an unimportant contribution of the nonlinear geometric effects to the structural performance of the vertical elements. Even for the 5,000-year scenario, during the precollapse phase of the columns, the small amplitude of the displacements seems to present a small contribution to the onset of collapse. Indeed, the maximum transverse displacements obtained in the north column for the 5,000-year scenario (during the precollapse period) were 6.2 cm (0.52% drift) on the shaft and 3.9 cm (0.21% drift) on the top. However, on top of the lateral walls, the maximum transverse displacements obtained during the precollapse period were 4.1 cm (0.20% drift) and 2.6 cm (0.42% drift) in the south and north walls, respectively (at the level of the cloister roof).

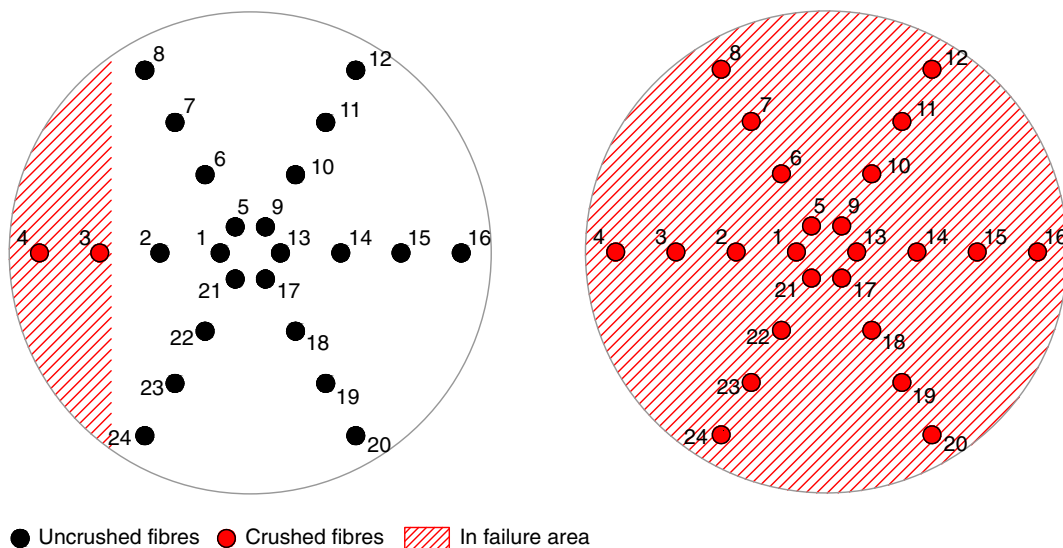
Fig. 14. Schematic representation of the compressive damage in the middle section of the shaft and in bottom section of the north column (seismic input 5000_M82_2).

Complementarily, a schematic representation of the damage found in the base and middle sections of the north column is depicted in Fig. 14. As can be observed, the collapse of the north column is characterized by a total failure in the base section (crushing of the effective section) and a partial failure in the shaft section (crushing of the most compressed fibers).

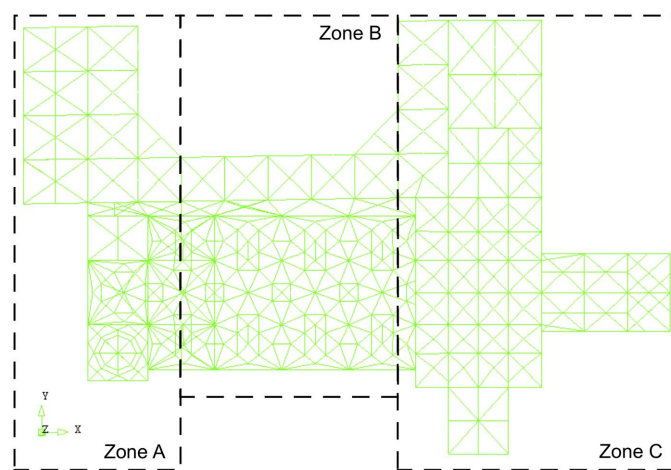
Fig. 16. Plan view of the finite-element model Zones A, B, and C indicated.

the substructures indicated in Fig. 16 [Zone A: tower + refectory + cloister (west part); Zone B: nave + cloister (central part); and Zone C: transept + chapels + apse + sacristy + cloister (east part)] partially. This is followed by a comparative analysis of the static and dynamic base shear results.

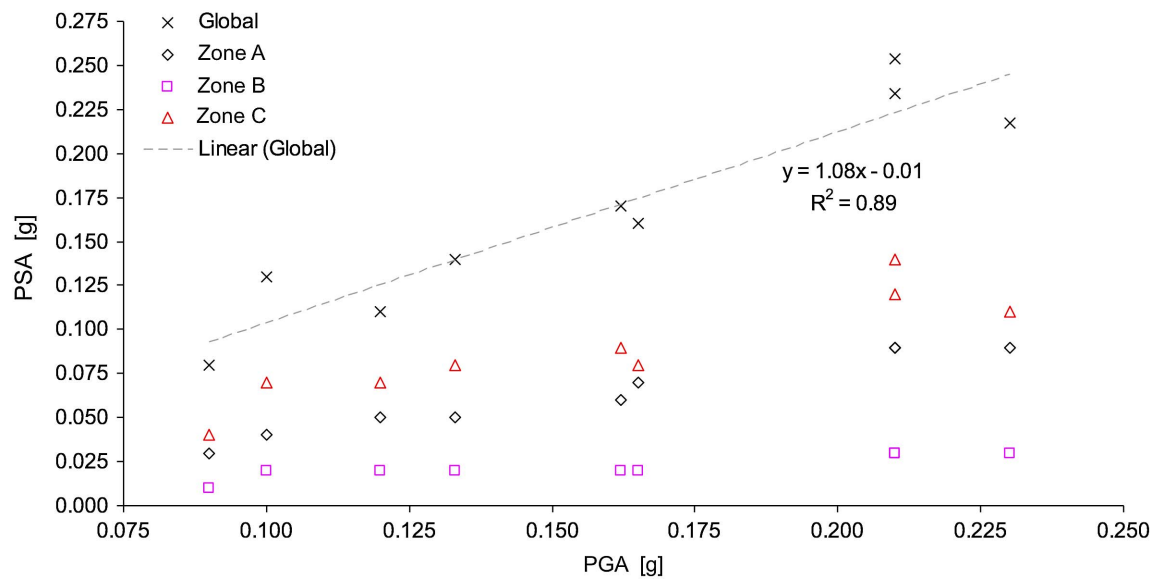
Fig. 17. Base shear coefficients pseudospectral acceleration (PSA) versus peak ground acceleration (PGA) of the seismic inputs used (average maximum values per structural Zones A, B, and C).

It is worth noting that the smaller the relative contribution, the greater the return period, due to the damage suffered (Fig. 17). Finally, despite their important role in the structural integrity of the church, the contribution of the nave columns to base shear was found to be insignificant for all seismic scenarios considered.

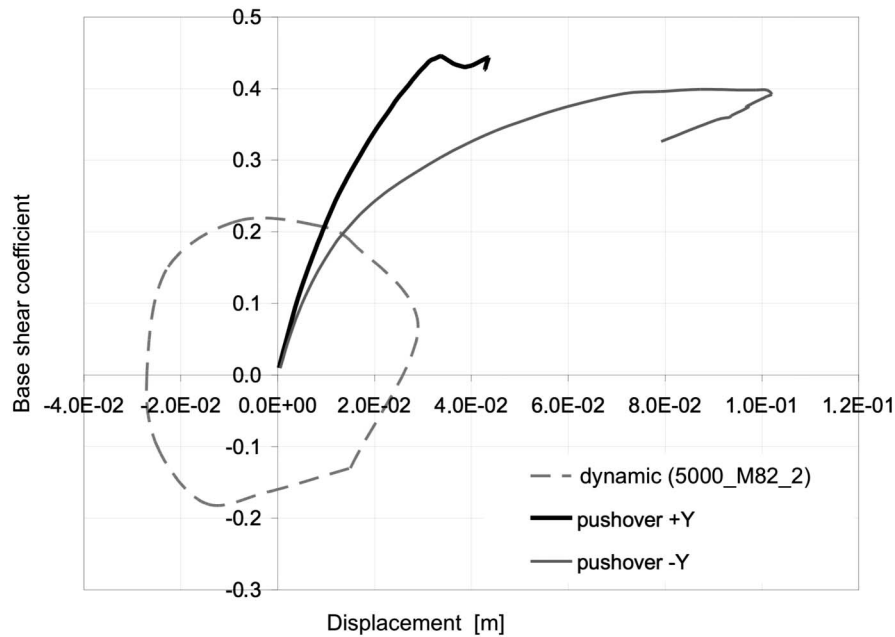
Fig. 18. Envelope of the dynamic base shear versus uniform pushover capacity curves (+Y, -Y).

dynamic analyses (for the 5000_M82_2 seismic input), both results are plotted together in Fig. 18.

A comparison of the outcomes obtained with aforementioned strategies shows that (1) the collapse modes obtained are rather different—the pushover analyses led to the collapse of the columns, the walls, and the vault, whereas only the north column collapsed as a result of the dynamic analyses; (2) the collapse of the north column occurs in both strategies, with a similar configuration; (3) in the pushover analyses, the collapse of the north column has a larger load factor (0.44 g), while the south column collapse presents a smaller one (0.40 g); (4) the maximum dynamic global base shear coefficient (equivalent) is approximately half of the static shear coefficients (pushover); and (5) the columns had a residual contribution to the global base shear.

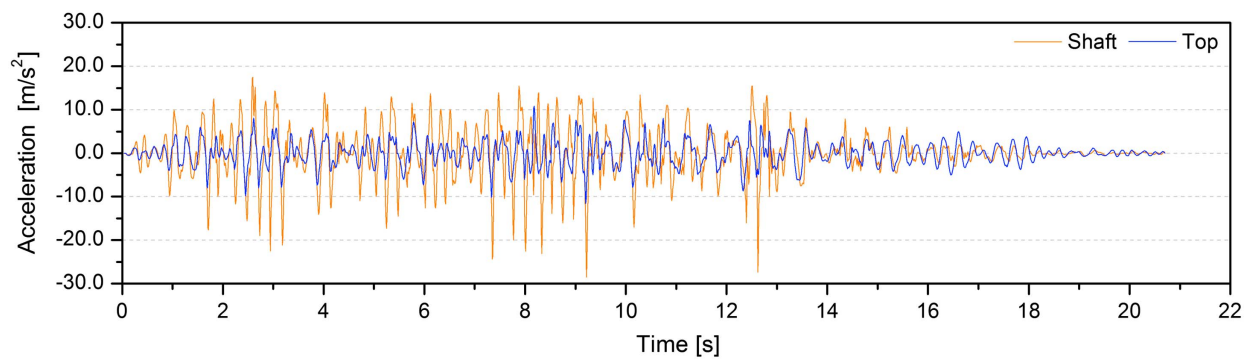
Fig. 20. Time history of accelerations in the north column shaft (at the top and middle sections) for seismic input 5000_M82_2.

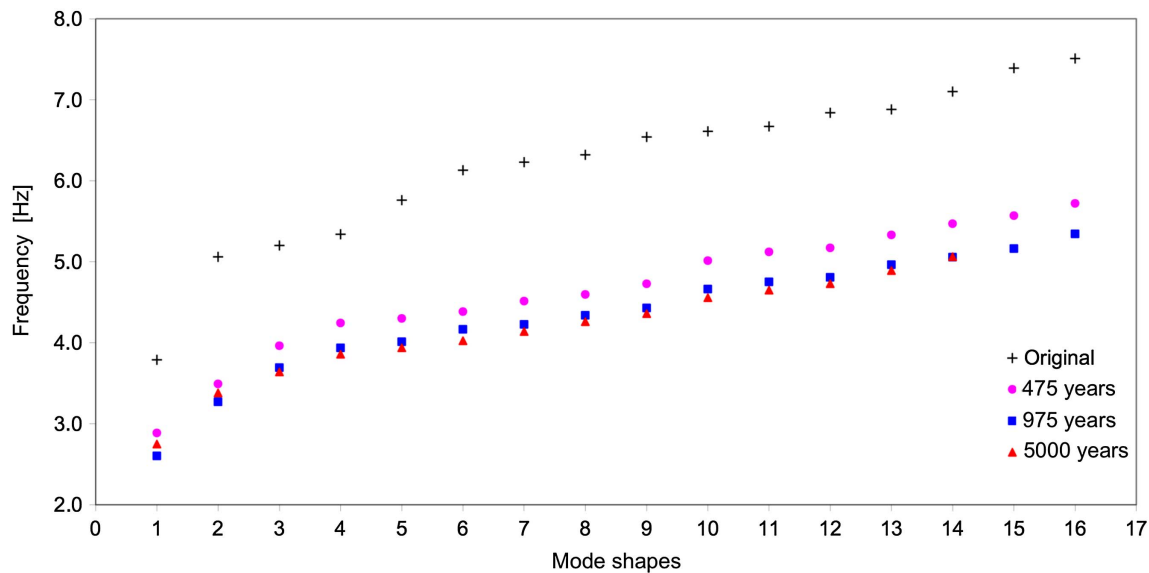
Fig. 21. Modal frequencies of the church, before and after seismic excitations (average values per return period).

In the cases for which no apparent collapse was observed, the numerical simulation of the seismic performance of the church was followed by a postaction eigenvalue analysis using the tangent stiffness of the damaged model, aimed at assessing the earthquake-induced decay in natural frequencies from the original to the damaged model. This type of analysis is not of interest when significant structural damage occurs. Significant damage, even when no collapse is observed, might render the stiffness matrix ill-conditioned with the results of such a modal analysis to be of no value. Fig. 21 shows the frequencies of the 16 first vibration

modes of the church found for both situations, before and after the seismic excitations for each return period. Some important remarks can be made based on the modal frequency decays, reported in Fig. 21.

First, there is an average and nearly uniform reduction of about 1.5 Hz in the modal frequencies of the church (i.e., the first 16 numerical frequencies were reduced from 3.8–7.51 Hz to 2.8–5.3 Hz), suggesting a uniform stiffness reduction due to earthquake-induced damage (essentially, cracking) on the church.

Second, despite the different characteristics of the seismic inputs (both in duration and PGA), the reduced contrast found in the average modal frequencies of the church may indicate that the resulting structural damage is more associated with the frequency content of the adopted accelerograms rather than with their peak ground acceleration or duration.

Third, in relative terms, the greatest levels of damage occur for the lowest severe scenarios, with a return period of 475 years.
