Energetic Rehabilitation in Buildings: Cost-Effective Solutions to Minimise Thermal Bridging

Maria Isabel Abreu and Jorge Lopes

Department of Construction and Planning, Polytechnic Institute of Bragança. Apartado 1134, 5301-857 Bragança, Portugal; isabreu@ipb.pt; lopes@ipb.pt

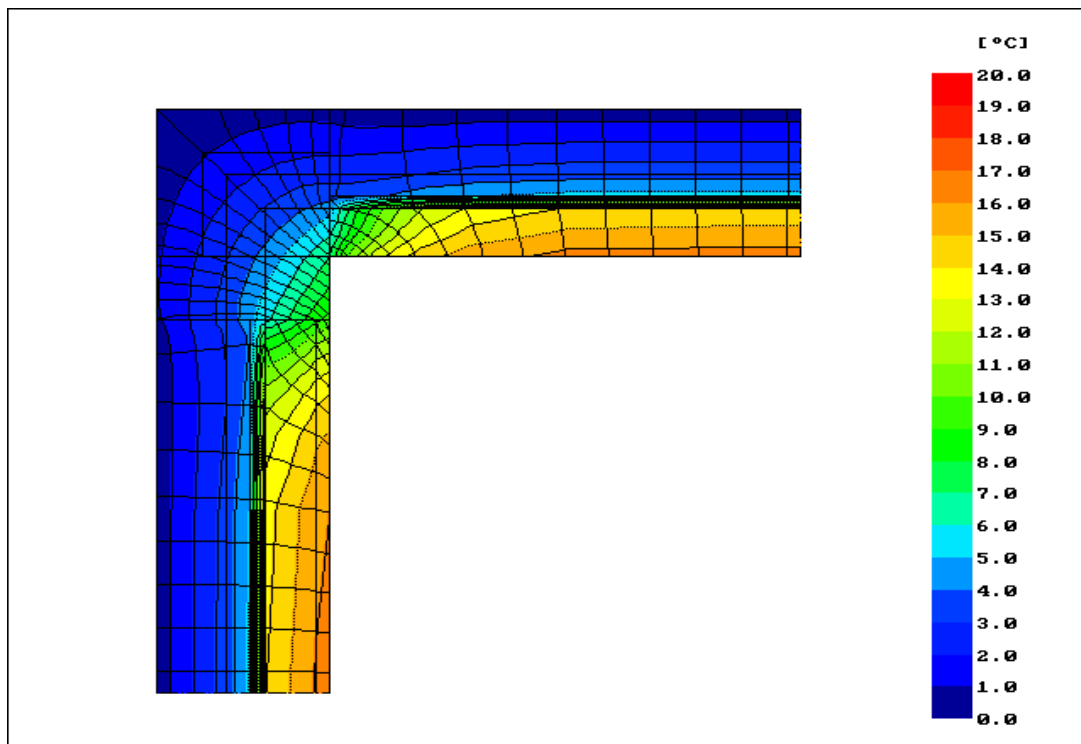
Fig. 1: Heat flow lines and isothermals in a junction between two vertical walls.

Another consequence of thermal bridges is the cooling of the inner surfaces on those zones, resulting in higher condensations and the growth of moulds, creating poor air quality conditions. Figure 1 illustrates the heat flow lines and the isothermals on the corner between two exterior walls. We can identify in Figure 1 the increase of the number of heat flow lines and the reduction of the temperature near the junction, relative to the current zone.

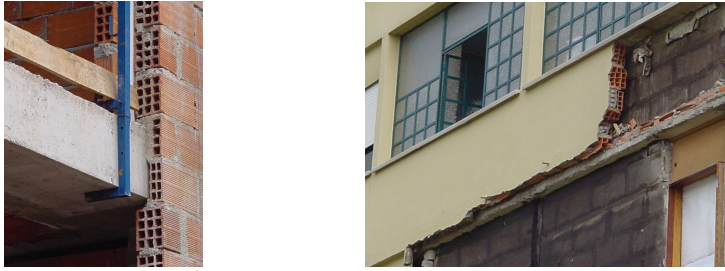
Fig 2: Deficient brick covering on the edge of a beam creating insufficient width support of the exterior leaf and the collapse of an outer leaf.

- Insufficient support of the outer leaf of the cavity wall (Fig 2).
- Increasing the effects of deformations of the masonries (non-structural cracking, detachments renderings, etc.).
- Instability and even collapse of the outer leaf masonry (Fig 2).

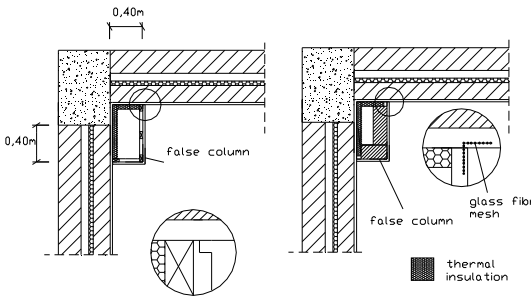
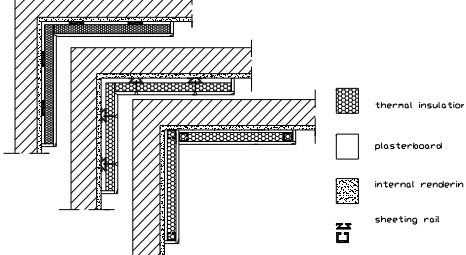
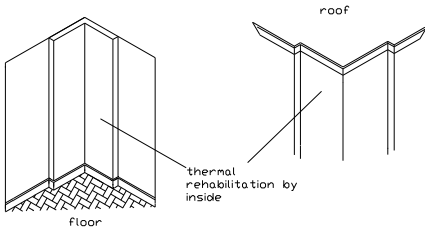
Fig. 3: Thermal rehabilitation by the outer surface in the junction between two external walls.

<p>REHABILITATION BY THE INNER SURFACE- Junction between two exterior walls</p> <p>Could be associated with an outer constructive rehabilitation</p>		
<p>Rehabilitation Solution:</p>

<p>surface temperature factor $\tau = 0,30$</p>	
<p>Guidelines:</p> <ul style="list-style-type: none"> - increase locally the thermal resistance - minimize the thermal insulation interruption 		
<p>Construction Details</p>		
<p>Thermal Insulation Thickness = 0,03 -0,04 m</p>

<p>Thermal Insulation Thickness = 0,03 / 0,04 m</p>

<p>Detail of the punctual thermal rehabilitation with dry-lining or plasterboard panels with vapour control layer</p>
<p>Final aspect</p>

Presented below are some simple constructive rehabilitation solutions that showed, through numerical simulation, good performance results. We see, for example, the junction between two exterior walls (Figures 3, 4, 5).

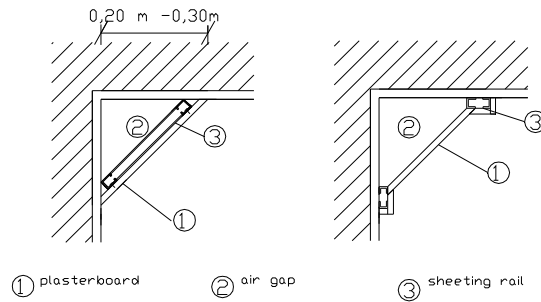
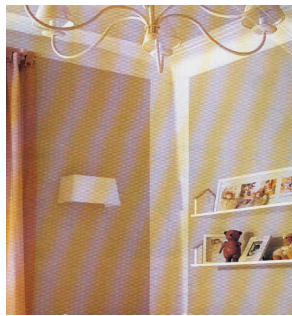
Fig. 4: Thermal rehabilitation by the inside surface in the zone of junction between two exterior walls.

REHABILITATION BY THE INNER SURFACE - Junction between two exterior walls

- modification of the inner surface geometry

surface temperature factor $\tau = 0,29$

Construction Details

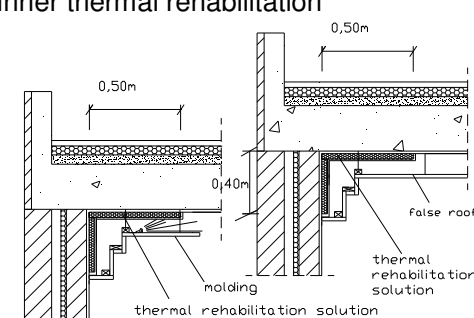
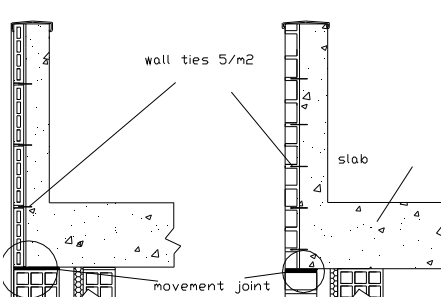
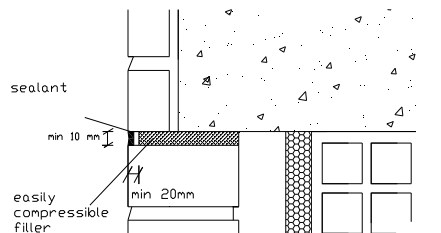
Fig 6: Constructive and thermal rehabilitation with maintenance of the brick covering.

REHABILITATION BY THE INNER SURFACE AND CONSTRUCTIVE MAINTENANCE OF THE BRICK COVERING - Junction between an exterior wall and a roof slab	
<p>Rehabilitation Solution:</p> <ul style="list-style-type: none"> - increase locally the thermal resistance - minimize the thermal insulation interruption

<p>surface temperature factor $\tau = 0,30$</p>
Construction Details	
<p>Inner thermal rehabilitation</p>

<p>Constructive details of a solution with insulated panels by the inner surface</p> <p>Thermal Insulation Thickness = 0,03-0,04 m</p>	<p>Constructive rehabilitation of the brick covering and junction</p>

<p>Constructive detail with the introduction of wall ties</p>

<p>Constructive detail of a horizontal movement joint</p>

Another example is the junction of an external wall with a roof slab, where both thermal and constructive rehabilitation are sometimes required. Figure 6 illustrates the case of the maintenance of brick covering, while Figure 7 shows the solution that proceeds to its demolition.

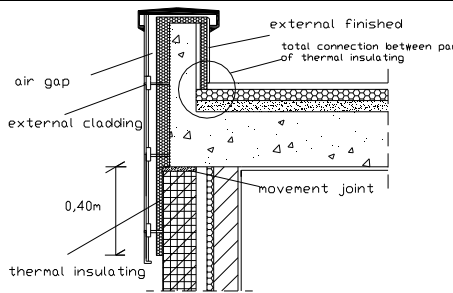
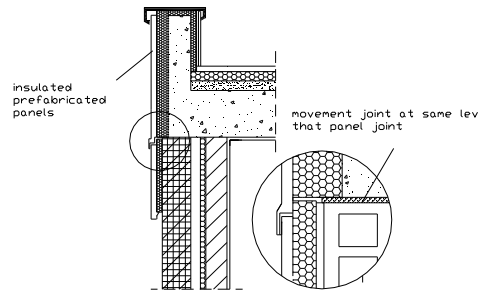
Fig 7: Constructive and thermal rehabilitation with substitution of the brick covering.

REHABILITATION SIMULTANEOUSLY BY THE INSIDE AND THE BY OUTSIDE WITH SUBSTITUTION OF THE BRICK COVERING - Junction between an exterior wall and a roof slab

- The concealment of existing cracking
- The existence of a movement joint and its protection

- increase locally the thermal resistance
- minimize the thermal insulation interruption.

superficial temperature factor $\tau = 0,29$

Thermal Insulation Thickness = 0,06/0,03 m
