Some refurbishment particularities: An older building case study

R A F Oliveira^{1*}, J Lopes², M I Abreu³

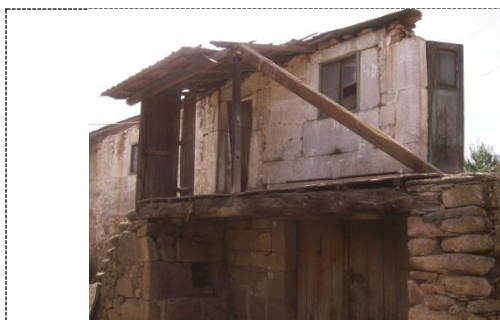
Figure 4. Principal façade with balcony.

The old building studied in this case study research was in ruins and threatens collapse of neighbouring buildings (figure 4 and 5), predicting 120 years old from existence. It is located in Montesinho village, near from Bragança city (Portugal), and it is integrated in Montesinho Natural Park which is preserved by their lovely nature. The building has not cultural interest individually but it contributes to building set of village preservation. The original building was in reality 2 separated buildings very similar, each one with 2 floors, stone walls, floors in wood and also roof structure in wood with slate tiles. Only the stones colours aspect, positions integrated with black roof slate tiles differentiate all landscape near and away. The design project was made in 2009 while the refurbishment works started in 2010 and it was finished in 2014.

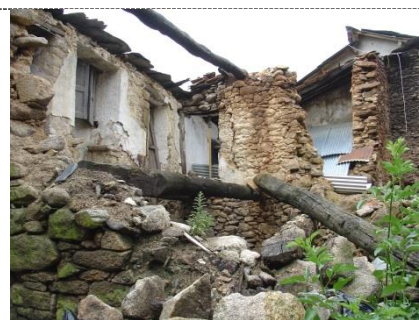
Figure 5. Internal ruin collapse structures.

The old building included in the case study had all the interior structure and part of the exterior walls in ruins without any technical or economical possibility of recuperation, figure 4 and 5. A direct observation put in evidence some constraints and particularities described in table 4.

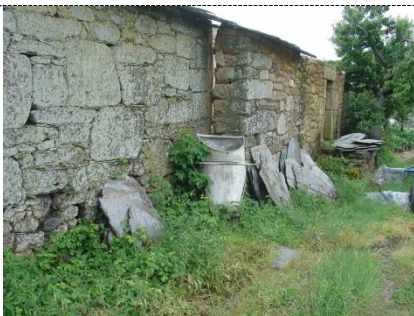
Figure 6. Posterior façade without connection and continuity.

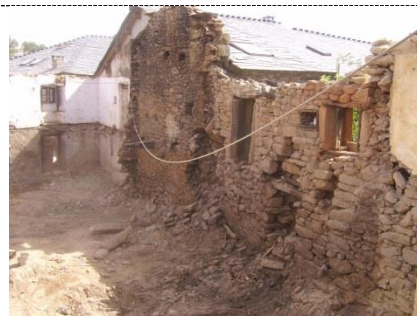
Figure 7. Adjoining building façades with little stone pieces. Electrical cables networks crossing the building

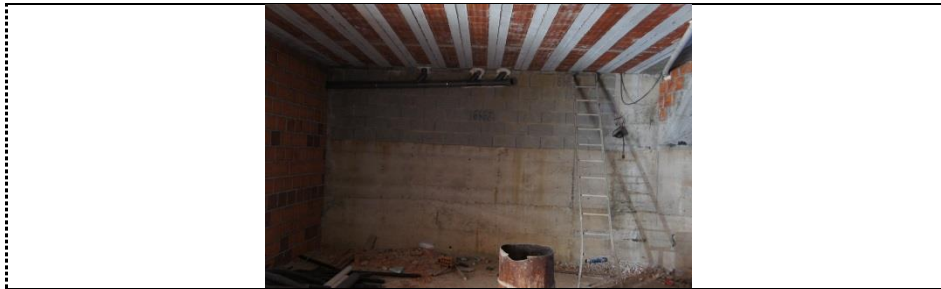
Figure 8. Lateral walls at first floor in concrete.

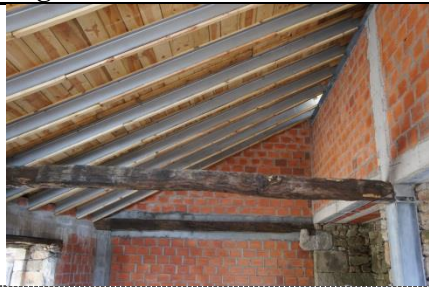
Figure 9. Roof with metal steel beams and wood.

P17 – The design project considered legal regulations superior than minimal requirements in thermal, acoustic and air renovation requirements.	A15, A16
P18 – The building need all infrastructures and networks connections.	A13
P19 – The building has some peripheral containment needs, and it needs some simple solutions which promoted the existing elements reinforcement of all walls.	A6, A10, A12
P20 – Isolated foundations were built for pillars support and the exterior and lateral walls need reinforced concrete footing.	A5, A12, A16
P21 – The exterior walls are reutilized complying the regular requirements but lateral walls ante first floor level is reinforced with concrete walls (figure 8). The internal structure was built in steel profiles in pillars and beams. Some part of the beams transmits their loads to external walls with load levels very similar to original ones. The floors area was built in prefabricated concrete slabs. The roof structure was built in steel profiles and wood with slate tiles (figure 9 and 10)).	A15

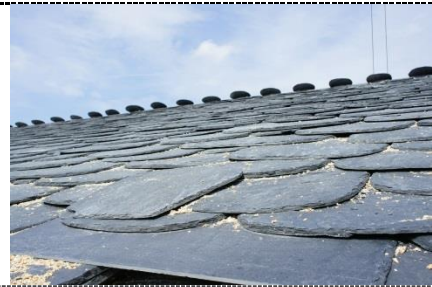
Figure 10. Roof with slate tiles.
