Building Services Engineering Research and Technology

BUILDING SERV ENG RES TECHNOL published online 14 November 2014
DOI: 10.1177/0143624414558720

A contribution for the improvement in thermal insulation of *tabique* walls coated with metal corrugated sheets

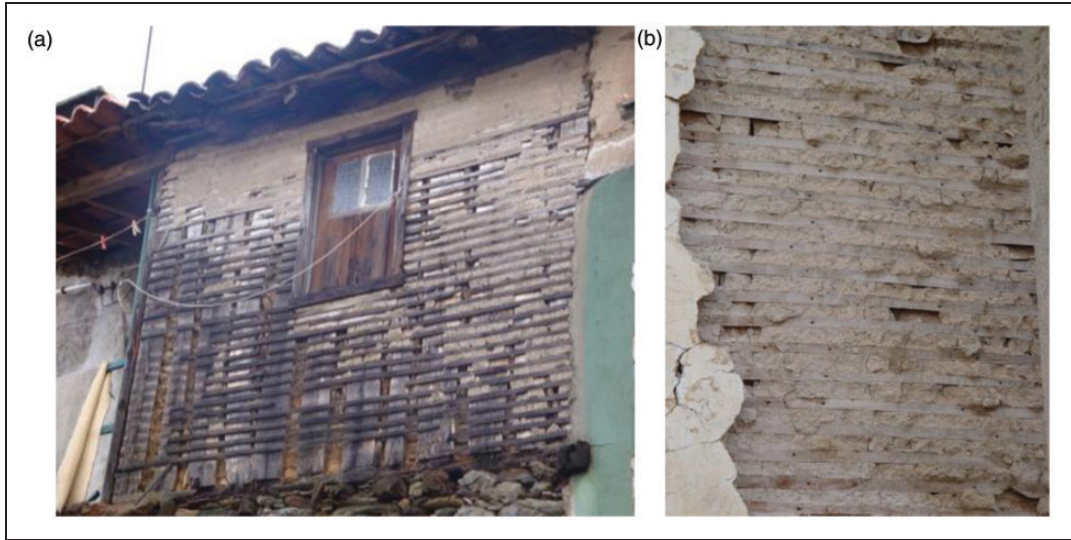
Figure 1. Components of a *tabique* wall: (a) timber frame with vertical and horizontal boards and (b) timber frame covered with earth render.

A *tabique* component, such as a wall (Figure 1), is formed by a regular timber frame covered on both sides by an earth render. The timber elements of the frame are nailed to each other and the most common timber frame solution is formed by vertical boards linked to each other by other horizontal timber elements.

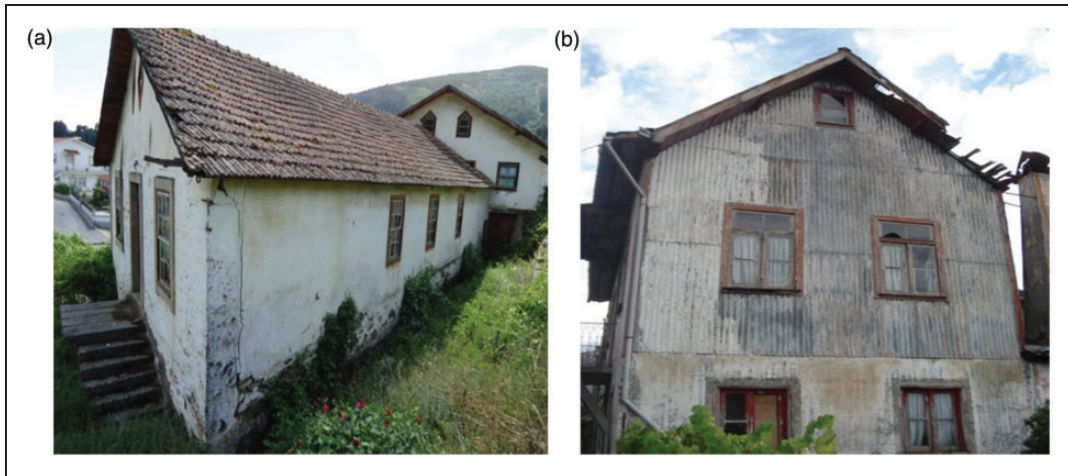
Figure 2. (a) Whitewash painting and (b) metal (steel or zinc) corrugated sheets as exterior types of finishing of Portuguese *tabique* dwellings.

The most traditional solution to make a building waterproof consists of adopting as a type of finishing wash painting (Figure 2(a)), metal (steel or zinc) corrugated sheets (Figure 2(b)), slate boards (Figure 3a) or ceramic tiles (Figure 3(b)). The exterior covering may be used on all the facades or only on the ones that are more exposed to rain.

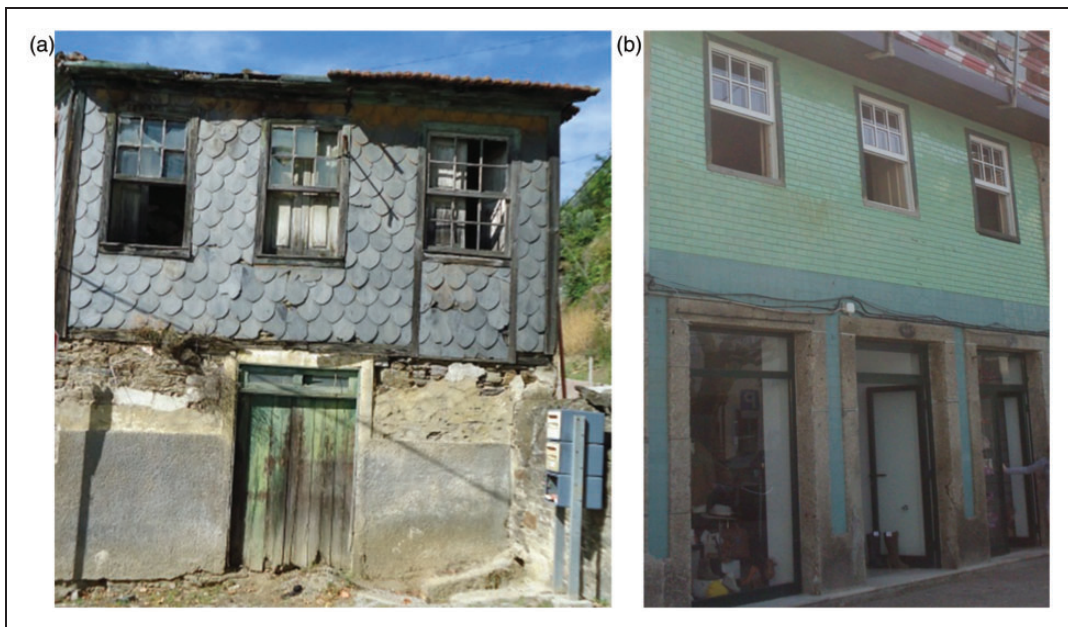
Figure 3. (a) Slate boards and (b) ceramic tiles as exterior types of finishing of Portuguese *tabique* dwellings.

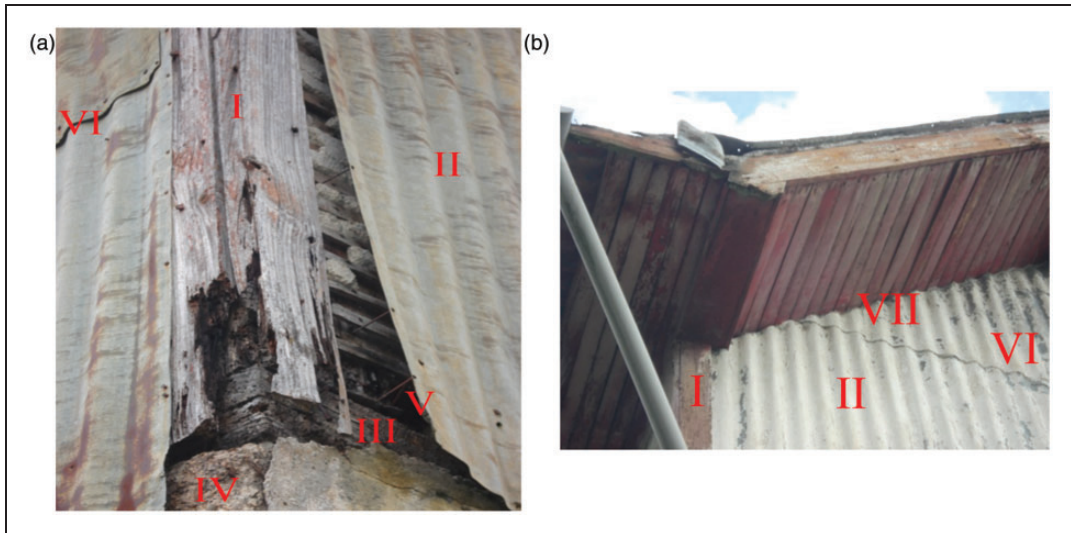
Figure 4. (a) Junction of walls and (b) roof abutment building details of the metal corrugated sheet coating. I: junction of *tabique* walls; II: metal corrugated sheets; III: timber frame; IV: granite masonry wall; V: nail; VI: connection of sheets; VII: roof abutment.

building solution of junction of two orthogonal external *tabique* walls covered by metal corrugated sheets consists of applying two timber boards, as detail I in Figure 4(a) indicates. They

are applied on the metal sheets and nailed to the main timber structure of the wall (III, Figure 4(a)). Figure 4(a) shows the nailed fastening process of the metal sheets (II, Figure 4(a)) to the

main timber structure of the wall (V, Figure 4(a)) and also presents a detailed example of the connection of metal sheets by overlapping (VI, Figure 4(a)). In addition, the typical Portuguese *tabique* building solution of having a granite masonry (IV, Figure 4(a)) on the ground floor and *tabique* walls placed on the upper floors is also highlighted in Figure 4(a). Figure 4(b) and Figure 5 show that additional timber elements are also usually applied to perform the required abutment of metal sheets in the constructive details of the roof, window and door.

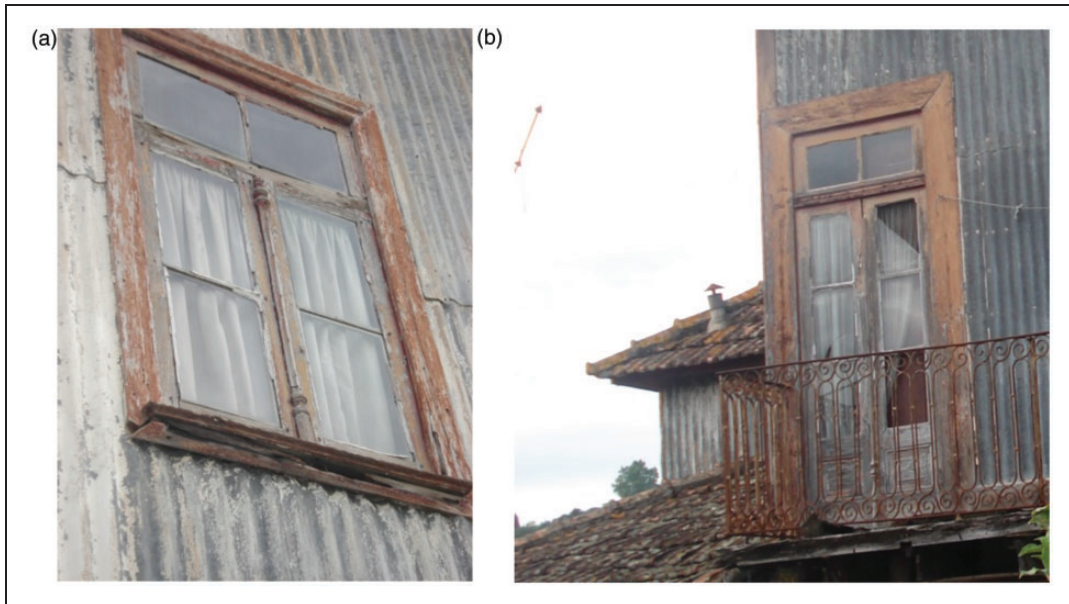
Figure 5. (a) Window and (b) door abutment building details of metal corrugated sheet coating.

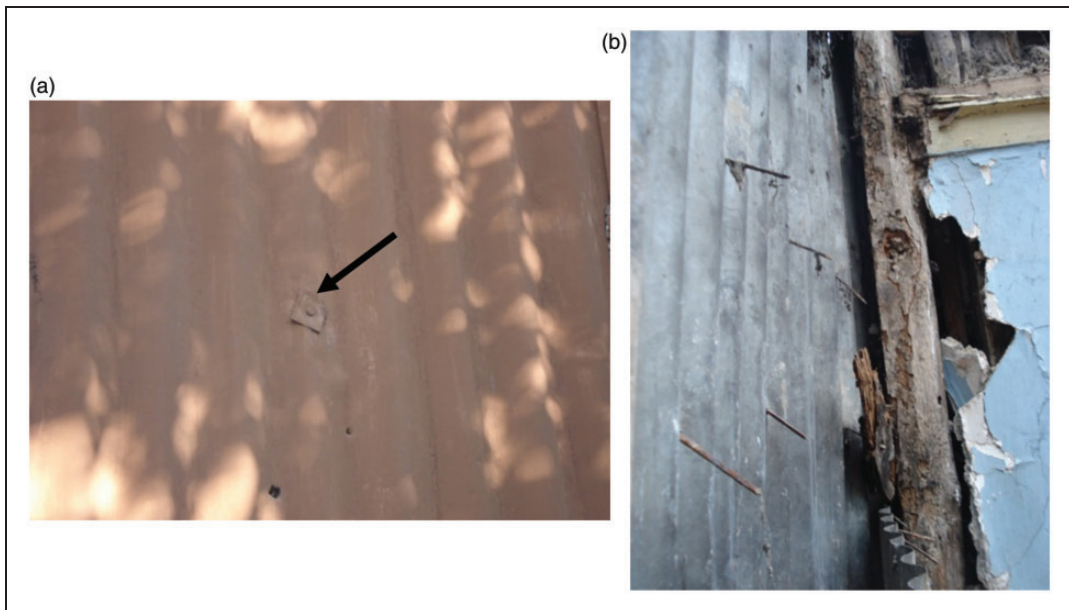
Figure 6. Nailed fastening details of metal corrugated sheet coating: (a) reinforcement and (b) inner face.

The nailed fastening system of the metal corrugated sheet to the main timber structure of the *tabique* wall is also an important building detail because it guarantees the stability of the coating. The inherent weight of the metal corrugated sheets, the wind pressure and the thermal variation are some of the loads that may be applied on the sheets. The nailed fastening system has to be adequate in order to allow transferring of these loads to the main timber structure of the wall. In this context, Figure 6(a) shows a traditional reinforcement solution of a nail fastening

by including an additional metal sheet (details in Figure 6(a)). With this solution, the intention is to increase the robustness of the structure under the dynamic wind effect on the metal corrugated sheet coating. On the other hand, Figure 6(b) shows the inner face of a metal corrugated sheet used as exterior coating of a *tabique* wall and its respective nailed fastening system. The type, the size and the lining up of the nails used, which are regularly applied as the fastening system, are technical aspects shown in this figure.

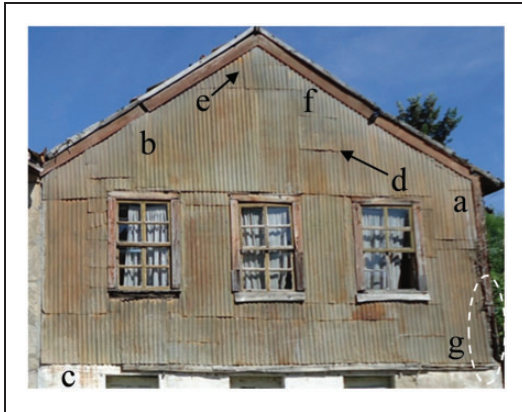
Figure 7. Complementary information concerning building details of the metal corrugated sheet coating of *tabique* walls.

a: junction of *tabique* walls; b: metal corrugated sheet; c: granite masonry wall; d: horizontal overlapping; e: vertical overlapping; f: roof abutment; and g: pathology.

In addition, Figure 7 presents the facade of another *tabique* building in which its exterior *tabique* wall, on the first floor, also has a metal corrugated sheet coating type applied. A comprehensive perspective of the above-identified building details can be obtained by seeing this figure, in particular, in terms of building details concerning the connection of sheets. It is clear that horizontal (d, Figure 7) and vertical (e, Figure 7) overlapping between adjacent sheets is required in order to build an adequate coating in terms of waterproof and thermal insulation behaviours. Meanwhile, an alternative

roof abutment solution of the metal corrugated sheet coating shown in Figure 4(b) is also presented in Figure 7. In this case, a timber board is nailed on the sheets in the junction of the coating and the roof (f, Figure 7). Furthermore, similar junction of *tabique* walls and window abutment solutions shown in Figures 4(a) and 5(a), respectively, are also applied in Figure 7. A typical pathology of this kind of building system (g, Figure 7) related to the degradation of the bottom of the timber boards that appear in the junction of the *tabique* walls is also featured in Figure 7. This type of pathology is also highlighted in Figure 4(a).

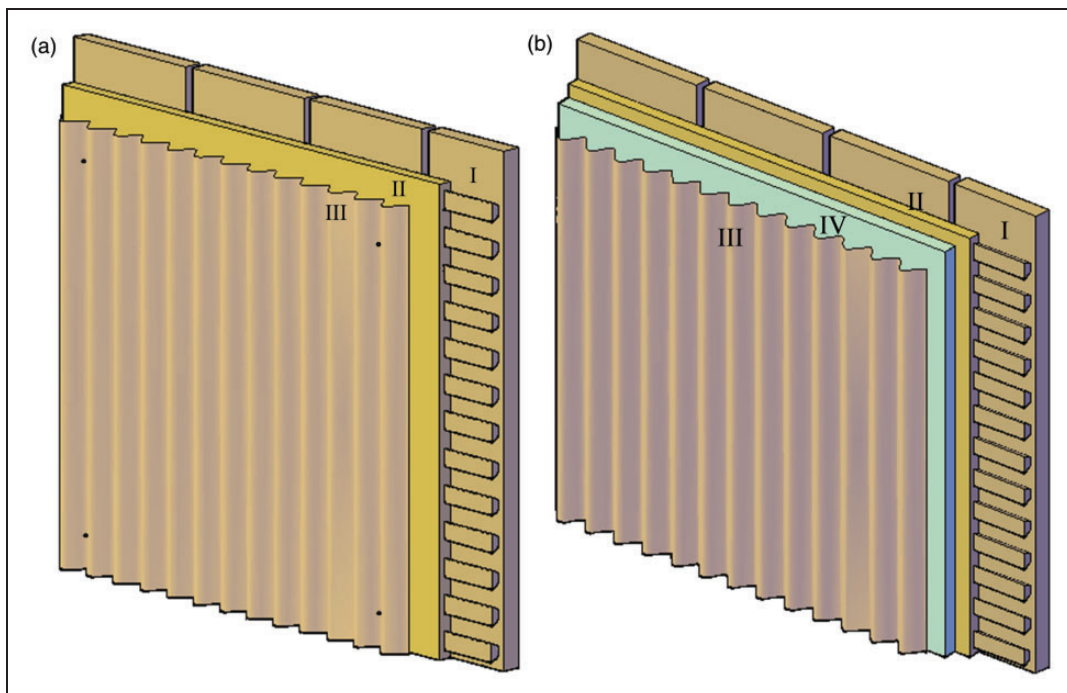
Figure 8. Samples of a *tabique* wall coated with metal corrugated sheets: (a) building system (case II) and (b) adopted thermal reinforcement solution (case III).

I: timber structure; II: earth render; III: metal corrugated sheet; IV: XPS board.
XPS: extruded polystyrene.

were separated from each other by 0.021 m. The earth render was applied on the timber structure, on both sides, and in order to completely cover the timber elements (Figure 8(b)). A 0.01 m thickness layer of an earth render was guaranteed. After the application of the earth render on the timber structure, the *tabique* wall sample was dried for 30 days under controlled thermal-hygrometric conditions of the laboratory. The thickness of the applied metal corrugated sheet was 0.007 m.

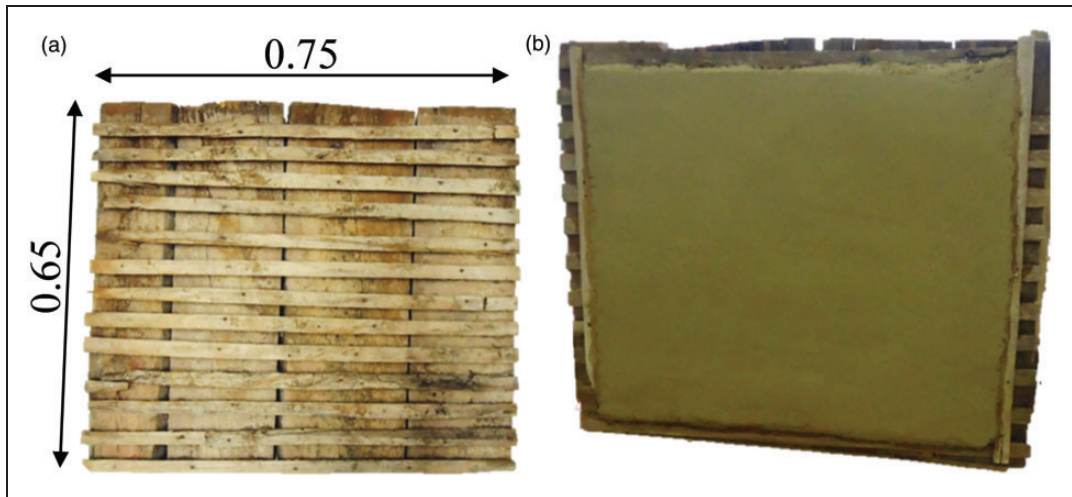
Figure 9. Preparation of the *tabique* wall sample (case I): (a) the timber structure (m) and (b) earth render application.

corrugated sheet and the earth render, as shown in Figure 9(b).

In this specific case, the timber structure of the sample (Figure 9(a)) was obtained from a real timber structure of a *tabique* wall of a Portuguese dwelling. The applied metal corrugated sheet on the outer face of the sample of the wall (IV, Figure 10) was also a portion of a real traditional metal corrugated sheet. On the other hand, it was not possible to maintain the real earth render of the wall because it had been removed as a result of the demolition process of the dwelling and also due to the transportation of the wall from the building site to the laboratory. This fact implied that an additional experimental work had to be done in order to find out an adequate earth render (i.e. similar to the real one) to apply in the *tabique* wall sample.

P. pinaster was the identified species of wood for the timber elements of the wall. The timber structural system of the wall is compound by vertical timber boards connected to each other by horizontal timber boards, which are nailed on the vertical boards on both sides

(Figure 9(a)). In terms of medium values, the vertical boards presented a width of 0.164 m, a thickness of 0.025 m and a gap between them of 0.003 m. Meanwhile, the horizontal boards had the following average dimensions, width of 0.026 m and thickness of 0.018 m, and they

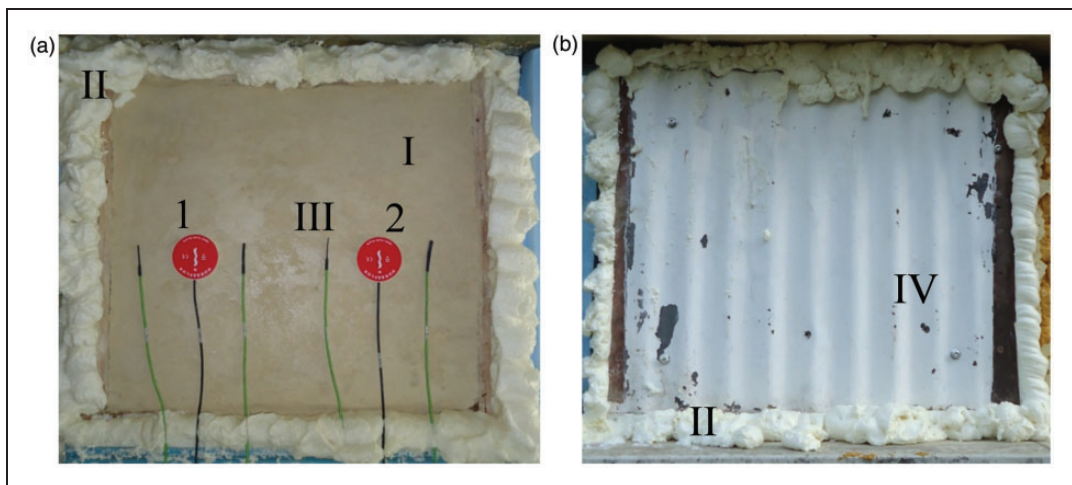
Figure 10. Thermal insulation test performance of the *tabique* wall sample coated with metal corrugated sheets: (a) inner face and (b) outer face.
I: inner face of the wall sample, earth render finishing; II: polyurethane foam; III: temperature sensors; IV: metal corrugated sheet; and I and 2: heat flowmeters.

After the drying process, the sample of the *tabique* wall coated with metal corrugated sheet replaced an existing window in the north-east facade of the test room (Figure 10). The sample was carefully fixed to the wall of the test room using polyurethane foam (II, Figure 10). This solution for fixing the sample also avoided undesirable insulation voids, thermal bridges, non-insulated headers and other defects that may compromise the feasibility of the final thermal results. In

According to ISO 9869:1994¹³ and the research of other authors, the recommended equipment comprises two heat flow meters (1 and 2, Figure 10(a)), four surface temperature sensors (III, Figure 10(b)), two ambient temperature sensors, a data logger and a computer. Both heat flow meters and surface temperature sensors were fixed in the middle of the inner face of the wall (Figure 10(a)). Meanwhile, the interior and the exterior temperatures ($Ti(n)$ and $Te(n)$) were measured using thermohygrometric equipment kept indoors and outdoors, respectively. Based on the standard,¹³ the accuracy of heat flow meters and temperature sensors is about 5% when these instruments are calibrated. According to the experimental methodology adopted in this research work, the conditions in which the tests were performed and the type of element tested, an uncertainty of the results varying from 14% to 28% is expected. Therefore, this aspect has to be considered in case of extrapolating the results obtained in this article.

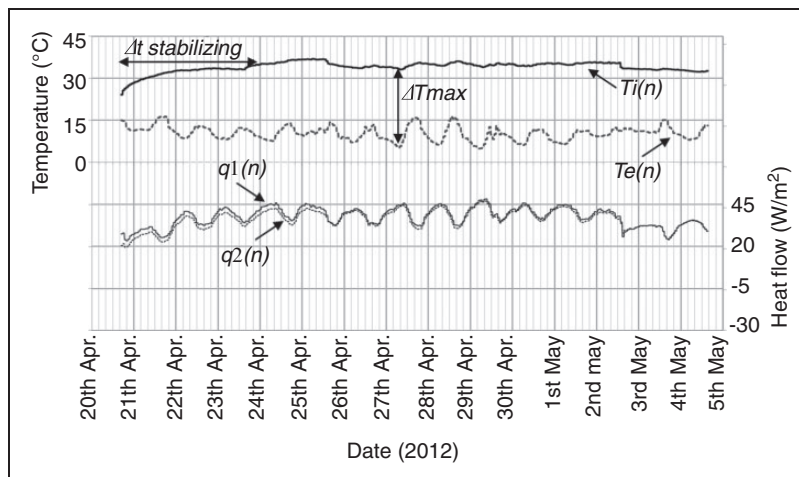
Figure 11. Collected data of the thermal insulation test of the sample of the *tabique* wall (case I). $Ti(n)$: interior temperature; $Te(n)$: exterior temperature; $q1(n)$ and $q2(n)$: heat flow measured by the heat flow meters 1 and 2, respectively; $\Delta Tmax$: maximum thermal gradient; Δt stabilizing: required time to stabilize the interior temperature of the test room.

The temperatures ($Ti(n)$ and $Te(n)$) and the heat flow across the wall model ($q1(n)$ and $q2(n)$) were measured continuously (in between 10 min intervals (n)). The heat flow meters 1 and 2 (Figure 10) measured the heat flow that occurred across the wall sample $q1(n)$ and $q2(n)$, respectively. The thermal behaviour test of the sample related to case I was performed in April 2012 and May 2012, with the duration being 14 days (Figure 11). On the other hand, the thermal behaviour test of the sample related to case II was performed in October 2012 and November 2012, the duration being 7 days (Figure 12). Meanwhile, the test of the sample of the *tabique* wall coated with metal corrugated sheet reinforced with the XPS board (case III) took place in September 2012 and October 2012, over a period of approximately 10 days (Figure 13). This testing schedule was

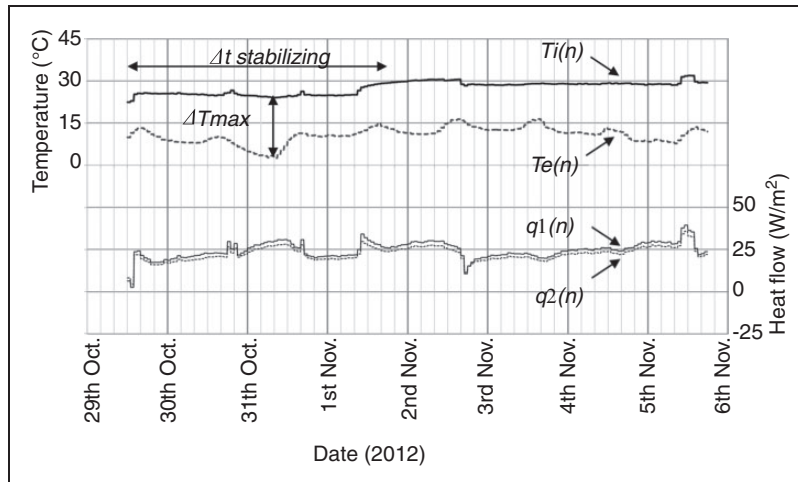
Figure 12. Collected data of the thermal insulation test of the sample of the *tabique* wall coated with metal corrugated sheets (case II).

$T_i(n)$: interior temperature; $T_e(n)$: exterior temperature; $q_1(n)$ and $q_2(n)$: heat flow measured by the heat flow meters 1 and 2, respectively; ΔT_{max} : maximum thermal gradient; $\Delta t_{stabilizing}$: required time to stabilize the interior temperature of the test room.

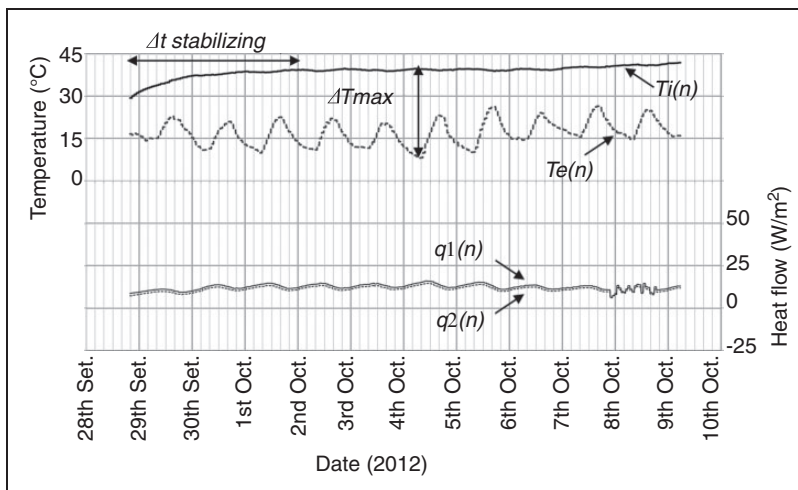
Figure 13. Collected data of the studied reinforcement thermal insulation solution (case III).

$T_i(n)$: interior temperature; $T_e(n)$: exterior temperature; $q_1(n)$ and $q_2(n)$: heat flow measured by the heat flow meters 1 and 2, respectively; ΔT_{max} : maximum thermal gradient; $\Delta t_{stabilizing}$: required time to stabilize the interior temperature of the test room.
