CODE 548

EXPERIMENTAL TESTS OF SCHIST MASONRY WALLS STRENGTHENED WITH GROUTS

Luso, Eduarda¹

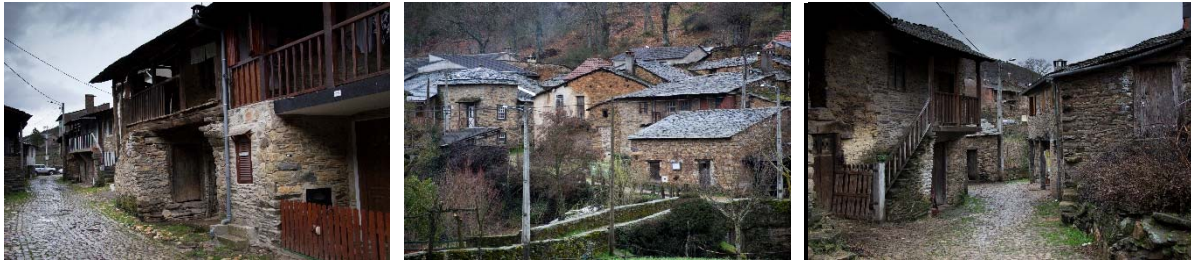
Figure 1: Buildings with schist masonry walls

The use of stone masonry is very common in many historic constructions, both architectural monuments and whole urban and rural centers, especially in Europe, many of which generally made of various and very poor materials namely different type of stones (granite, schist or limestone) and low strength lime mortars, arranged in irregular morphologies [1]. The common typology construction encountered is the multi-leaf masonry wall, which is characterized by a large presence of voids and very sensitive to brittle collapse. Schist constructions, in particular, are an important cultural, architectural and historical legacy in northeastern of Portugal and also in cross-border zone with Spain, whose preservation is of importance, see Figure 1. Schist masonry typically has two types of constructions: with mortar joints, usually with mixtures based on clay or lime; or with dry joints, normally used in encircling walls, mills and shelters.

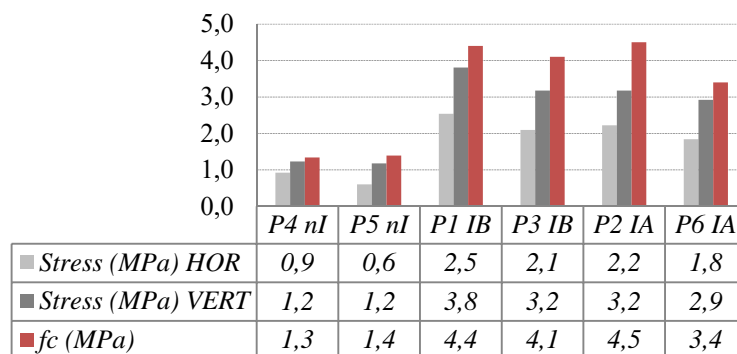
Figure 6: Compressive stress level for which the first crack with horizontal (*Stress HOR*) and vertical (*Stress VERT*) direction appears vs. maximum compressive strength (*fc*)

Regarding to the present study, the appearance of the first horizontal and vertical cracks, as well as the respective applied load, is given in Figure 6.

On average, the first horizontal cracks appear at about 50% of the maximum load, while vertical cracks arise at about 80% of the maximum load. The crack initiation was defined by the *lvdt*s and is rather objective, corresponding to a significant increase of measurements.

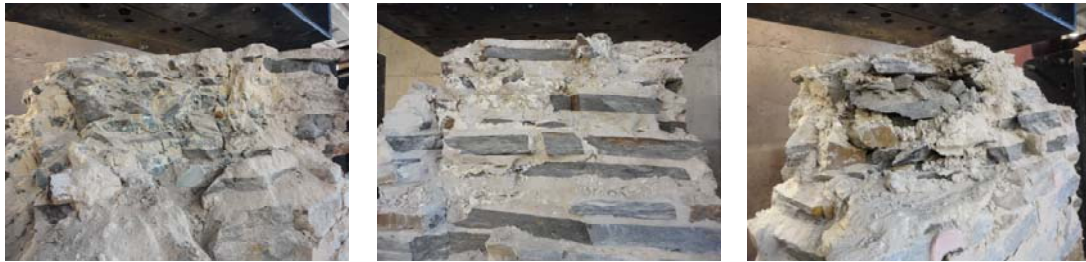
Figure 7: Appearance of the interior of the wall after dismantling: (a) P1; (b) P6; (c) P4

The appearance of the interior of the injected walls during the dismantling can be seen in Figure 7 (a) and (b). Comparing these results to those of Figure 7 (c) where it is clear the existence of voids in the non-injected specimens, it is possible to check the injected grouts were very well distributed for both grout types, filling the voids of the wall.
