THE SPECIFICITIES OF MANOR HOUSES AS BUILT HERITAGE: A CASE STUDY (PROHITECH2017)

Rui Oliveira*, Jorge Lopes* and Isabel Abreu*

* Polytechnic Institute of Bragança
e-mails: roliveira@ipb.pt, lopes@ipb.pt, isabreu@ipb.pt

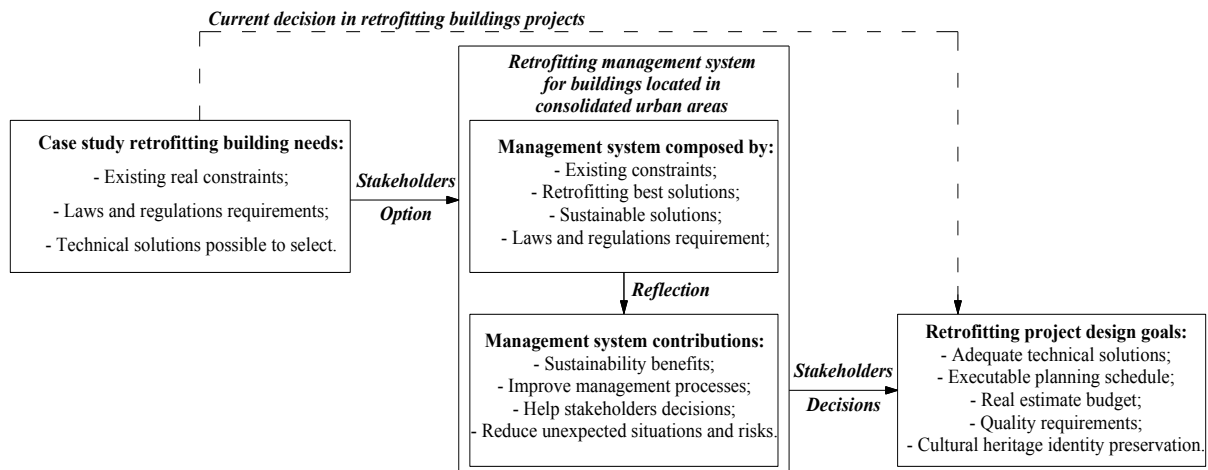
Figure 1: Framework scheme of management system uses for building retrofitting works

Using a management system developed in a research to support old building rehabilitation projects, 39 from out of a set of 50 parameters is used in the study [6]. Each parameter has 5 possible choice options, classified from less sustainable to more sustainable. The idea and main goal consists in the reflection and option for viable solutions in building rehabilitation project design project and relate them with the recommendations from each management system parameter. And whenever possible, it is chosen the option for solutions that have more benefits to sustainability.

Each parameter has a description about the contents and the main goal proposal, such as it has a set of possible solutions classified from 1 (less sustainable) to 5 (more sustainable). The solutions classified in 2 are considered conventional ones and without increasing sustainability levels. The management system utilization is optional, but their uses make the design project more consistent in technical points and also it reflects a set of contents sometimes ignored or without a careful reflection in similar rehabilitation projects, figure 1.

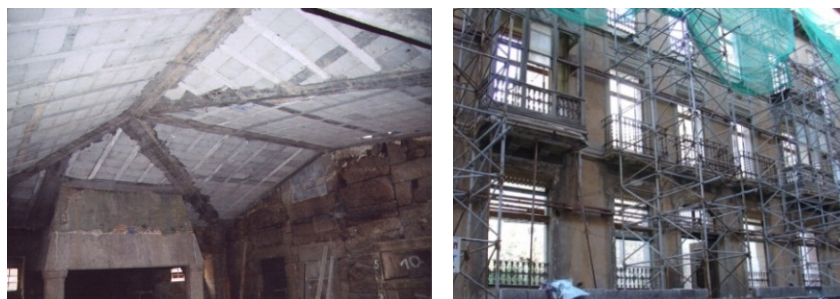
Figure 2: Examples of building retrofitting works using only the external walls

Building rehabilitations consists of “*reparation, extended renewal and modification of a building in order to leave it according to the economical or functional criteria equivalent to those requested to a new building conceived for the same purpose*” [9]. This consists in the actions needed to the recover buildings’ functional performance, through resolution of physical and constructive faults and functional adaptations to improve comfort and performance conditions [3]. These interventions consider the re-use of pre-existing materials, fitting them to promotion of sustainable practices and keeping, as much as possible, the buildings’ original features. Meanwhile some interventions on these buildings are built as new building constructions, with total destruction of the existing elements, using only the exterior walls, contradicting the rehabilitation concept, figure 1.

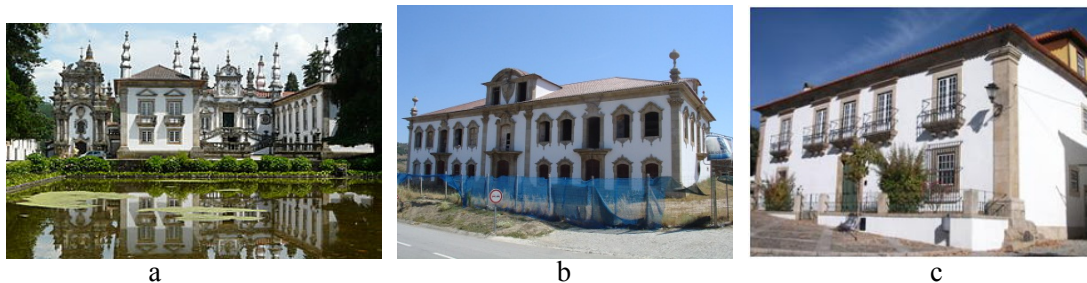
Figure 3: a) Mateus Palace, in Vila Real (National interest - National Monument); b) Pimenteis Manor house, in Mogadouro (Public interest); c) Correia Alves Manor house, in Moimenta da Beira (Municipality interest)

There are some criteria to asset the interest and relative value attending to architectonic or artistic value, landscape, historical-documentary and cultural to local, regional or national scale [13]. The immovable cultural heritage may be listed as bearing national interest, public interest or municipal interest which depends from its relative value, figure 3.

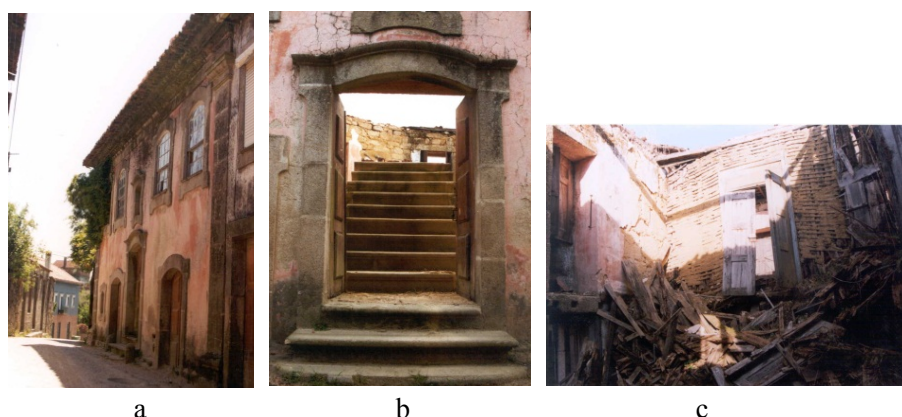
Figure 5: a) Principal façade of a Manor house in case study; b) Internal staircase; c) Interior ruins.

<ul style="list-style-type: none"> - (A10) Posterior façade has 8,5 meters of height, figure 6c) - (A11) The steps height of the internal stairs had 25cm to 28cm, figure 5b); - (A12) Some part of the posterior façade external wall had not some reinforcement and strengthened locking; - (A13) The building had not water and electricity networks; - (A14) Some doors closure and height need adaptation changes; - (A15) Floors and roof structure was supported in external walls, figure 6d). - (A16) The rehabilitation works has some technical complexity and some constraints; - (A17) Building has supported by consolidated granite rock in foundations;

(D) Rehabilitation works	<ul style="list-style-type: none"> - (D1) Lack of space in site works for materials deposit, figure 6c); - (D2) Site works access were narrow; - (D3) Cleaning needs were necessary for demolition and ruin waste, figure 5c); - (D4) Other existing constraints, figures 5a) and 5b); - (D5) Overhead electrical lighting lines on the street are distant 3m from the façade; - (D6) Narrow street which is the only connecting access within the village, figure 5a).

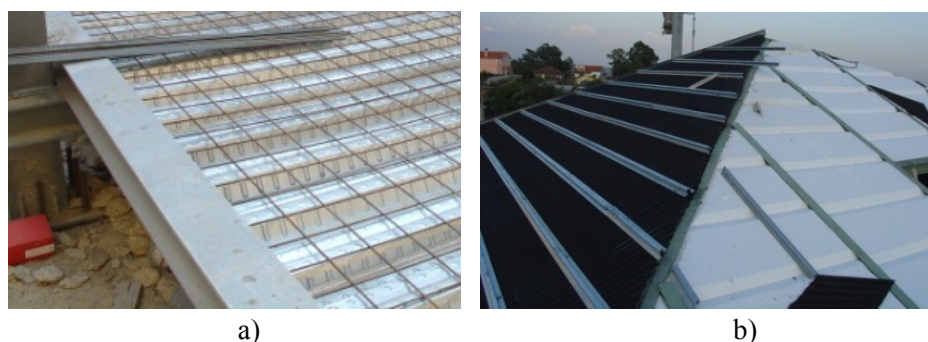
Figure 7: a) Metal steel frame on floors; b) Roof with metal steel beams, insulation and tiles supports

P17 – The building has minimal legal regulations superior than minimal requirements in acoustic and air renovation foreseen in thermal regulations.	A16
P18 – The building need all infrastructures and networks connections.	A13
P19 – The building has not peripheral containment needs, but it needs some simple solutions which promoted the existing elements reinforcement.	A12
P20 – Isolated foundations were built for pillars support and the walls do not need reinforcement.	A17
P21 – The exterior walls are reutilized complying the regular requirements. The internal structure was built in steel profiles. Some part of the beams transmits their loads to external walls with load levels very similar to original ones. The floors area was built in composite metal deck (steel decking for concrete floors slabs) (14 cm height), figure 7a). The roof structure was built in steel profiles and the tile batons also in steel profiles over thermal insulation, figure, 7b)	A15
