Residual Strength of a Steel-Concrete Composite Structure Subjected to a Design Seismic Event Followed by Fire

Pedro NOGUEIRO

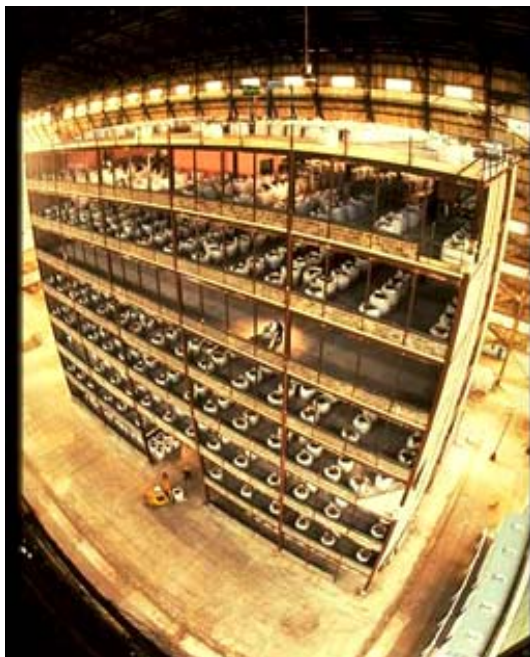
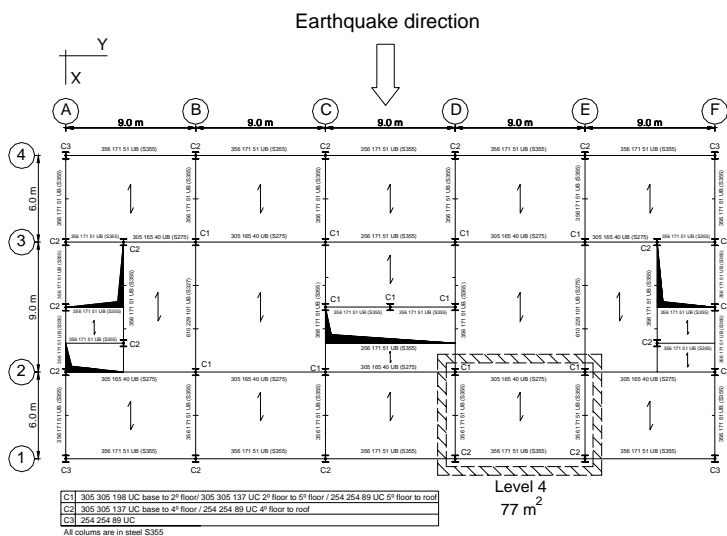
Fig. 2. a) The eight storey steel structure in Cardington; b) Identification of the fire compartment.

In order to allow calibration with real results from fire tests, the architectural and structural definitions of the eight-storey steel Cardington building were chosen as the reference case, adapted to comply with the Eurocode 8 seismic requirements. The steel building structure was built inside a former airship hangar located at Cardington, Bedfordshire, UK in the early 90's. It is a steel framed construction using composite concrete slabs supported by steel decking in composite action with the steel beams. It has eight storeys (33 m) and is five bays (5×9 m) by three bays (6+9+6 m) in plan (Fig. 2a). The structure was built as a no-sway frame with a central lift shaft and two end staircases providing the necessary resistance against lateral wind loads. The main steel frame was designed for gravity loads, the joints consisting of flexible end plates for beam-to-column connections and fin plates for beam-to-beam connections, designed to transmit vertical shear loads. The building simulates a real commercial office in the Bedford area and all the elements were designed according to British Standards and checked for compliance with the provisions of the Structural Eurocodes. The building was designed for a dead load of 3.65 kN/m² and an imposed load of 3.5 kN/m² [3]. The floor construction consists of a steel deck and a light-weight in-situ concrete composite floor (LW35/40), incorporating a A142 (142 mm²/m) anti-crack mesh in both directions. The floor slab has an overall depth of 130 mm and the steel decking has a trough depth of 60 mm.

The fire compartment was situated in the middle of the building enclosing a plan area of $11 \times 7 \text{ m}^2$, on the 4th floor, with a ceiling height of 4.185 m (Fig. 2b). A ventilation opening with $10.4 \times 1.27 \text{ m}^2$ is located as shown in Fig. 2. The walls consist of plasterboard plates (thermal conductivity $k=0.24 \text{ W/(mK)}$) with 0.0425 m thickness. Ceiling and floor are made of concrete ($k=0.7 \text{ W/(mK)}$) with 0.11 m thickness. As recommended by Buchanan [2], the columns and external joints and beam (approximately 1.0 m from the joint) were heavily protected. The material protection used was 15 mm of Cafco300 vermiculite-cement spray, with $k=0.078 \text{ W/mK}$.

The dynamic characteristics, related to the adopted earthquake direction (Fig. 2b), were evaluated for the three-dimensional (3D) structure and one two-dimensional (2D) internal frame E (Fig. 3 a). The 3D structure presents a first natural frequency of 0.41 Hz, while frame E shows an equivalent value of 0.31 Hz, both in good agreement. The structure is very flexible, a direct consequence of the PR joints. Fig. 3 b) illustrates the first mode of vibration for the 3D structure and Fig. 3 c) illustrates the first mode of vibration for frame E.

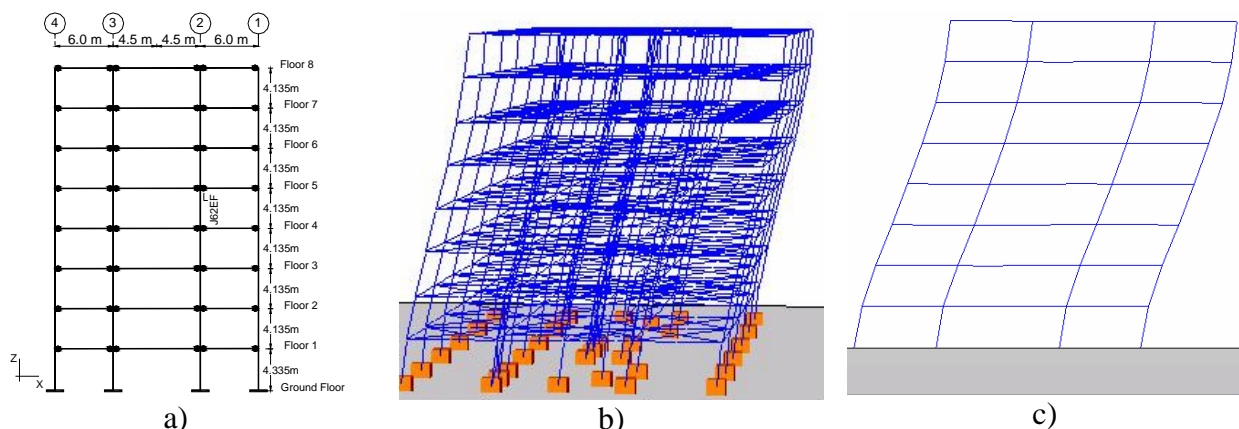
Fig. 3. a) Frame E; First mode of vibration, b) 3D structure; c) Frame E.

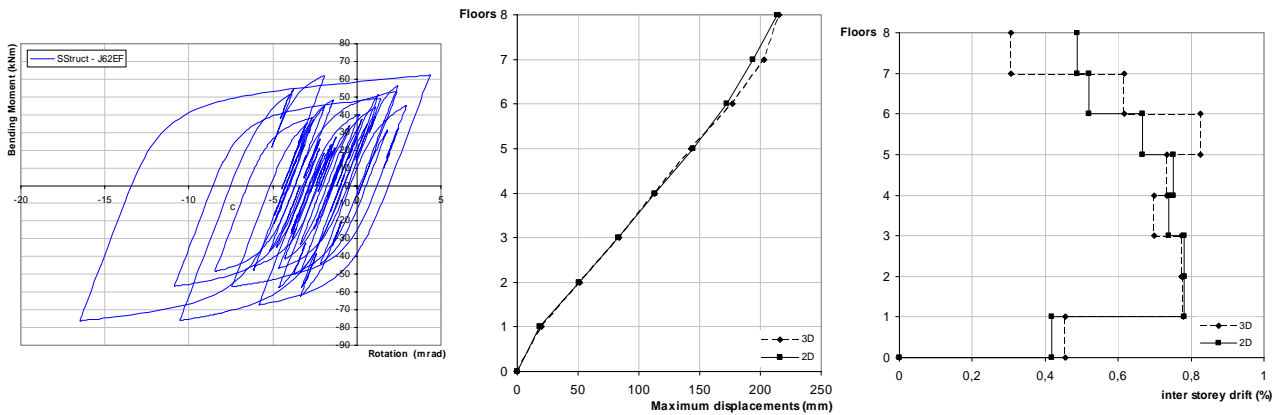
Fig. 4. a) Hysteretic curve for joint J62EF; b) Horizontal displacements; c) Inter-story drifts.

seismic strength and stiffness degradation. Because the beams are composite, with a moment resistance much higher than the resistance of the joints, the mechanical damage is mainly due to non-linear behaviour of the connections. The results show that the most stressed connections are located in the 5th floor, the same floor where the fire compartment is located. These connections exhibit approximately 50% of strength deterioration, as can be seen in Fig. 4a, and a energy dissipation of 4.87 KNm×rad. Figures 4b and 4c show the distribution with height of the maximum values of storey displacements and interstorey drifts, respectively. The maximum values obtained in the step by step procedure for both structures are very similar, as expected due to the symmetry and the uniform distribution of structural elements in plan in the 3D structure. The maximum values of displacements and inter-story drifts occur for the stiffer 3D structure.

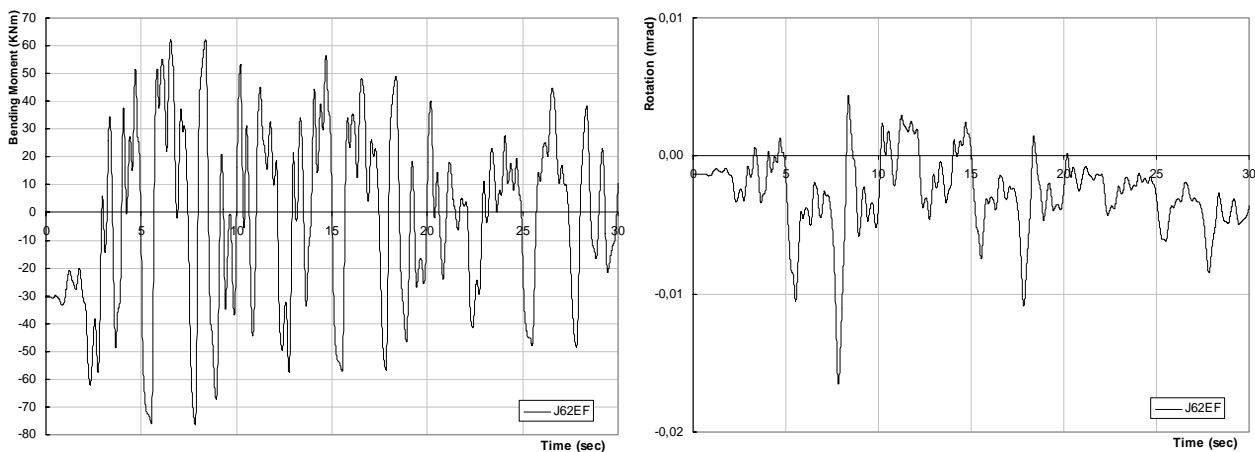
Fig. 5 shows the time histories for bending moment and rotation of the selected joint, that exhibits the maximum values of internal forces. Fig. 5 also shows that the maximum values of bending moment occur in the first 10 seconds, mainly due to the characteristics of the chosen accelerogram. The maximum value of rotation occurs after about 7.5 seconds, where some strength degradation is already noticed.

Fig. 5. Time-history results for joint J62EF a) Bending moment; b) Rotation.

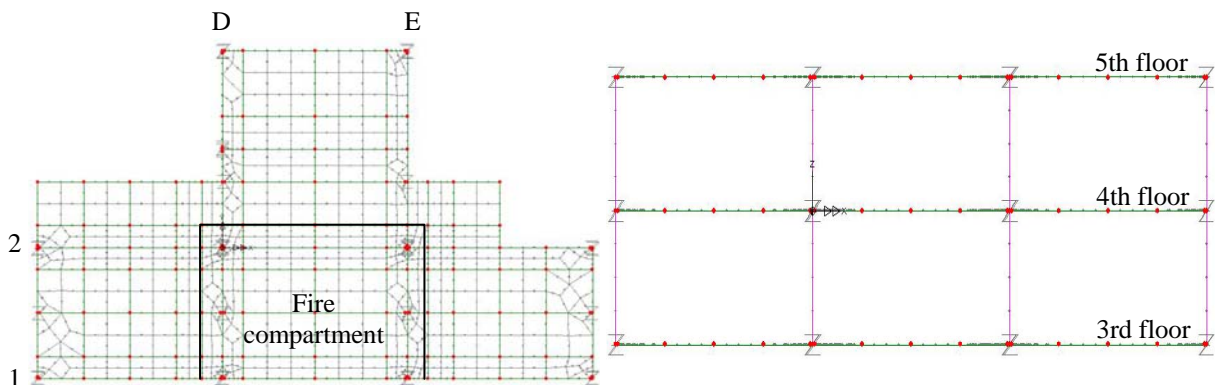
Fig. 6. Finite element mesh: a) plan view; b) front view

Following the earthquake, it is assumed that fire occurs in a confined compartment at the 4th floor of the building. This choice was dictated by the possibility of comparison with a natural fire experiment carried out in the Cardington building, as already explained above. To allow for a detailed assessment of the structural response under fire, a sub-structure was considered where all the major deformation would occur. The corresponding structural model is illustrated in Fig. 6.

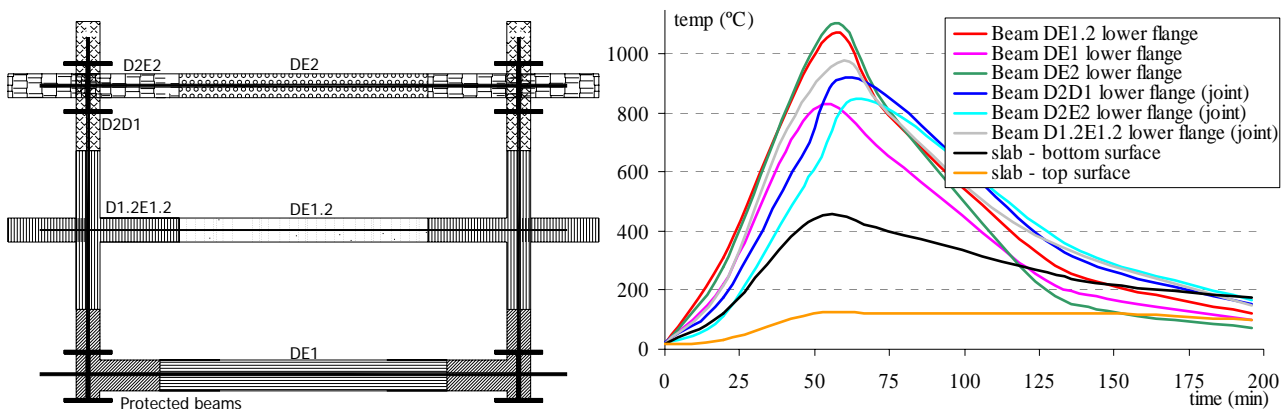
Fig. 7. Fire loading applied to the structural members within the compartment.

The fire loading corresponds to the results measured during the full-scale natural fire test [3]. It was applied directly to the steel beams and composite slab as a time-temperature curve. In the beams, the temperature varies along the length and within the cross-sections (a maximum gradient of 200°C is applied within the cross-section at the beam mid-span that decreases to zero near the joints); in the slab a temperature variation within the cross-section was also considered; finally, the protected beams and columns were assumed to remain at room temperature (Fig. 7).

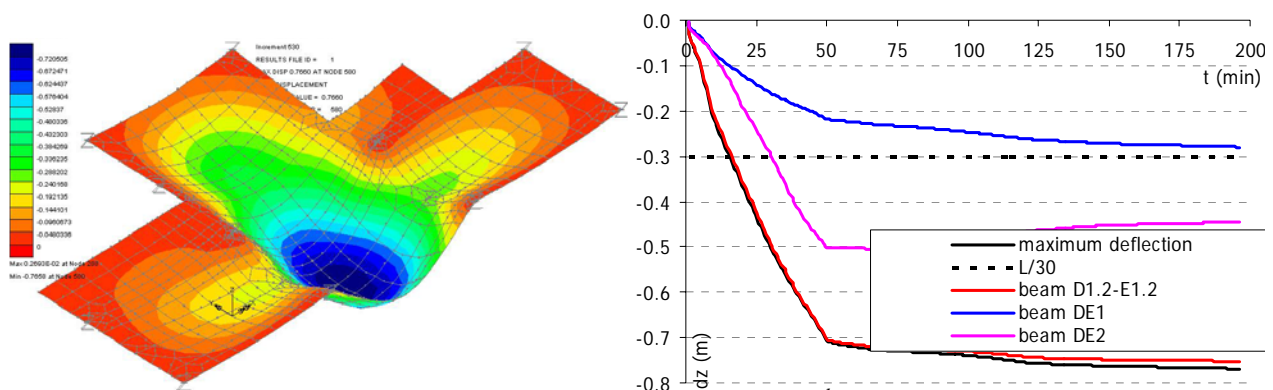
Fig. 8. a) Maximum vertical displacement contour for the 5th floor; b) Vertical displacement.

Fig. 8 shows the maximum vertical deformation contours for the 5th floor (0.78 m) and compares the development of the vertical displacements in the structural elements. Examination of the secondary beams shows that during the heating phase, the beam with the lower displacement is the beam near the window, because of lower temperatures, while the beam at the centre of the compartment shows the biggest displacement. In the cooling phase, the deflection of these beams remains constant, while the internal beam DE2 presents some partial elastic recovery. The dotted line in Fig. 8b illustrates the usual failure deflection limit state of $L/30$.
